# RINCONADA WATER TREATMENT PLANT INTERIM SITE RESTORATION PROJECT

Contract C0670, Project No. 93294057

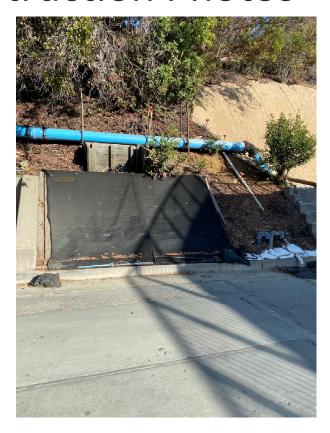
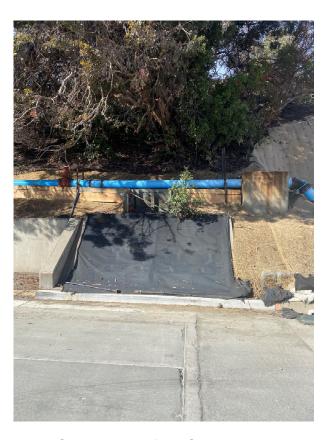
Concrete Pipe Support Work – Before and After

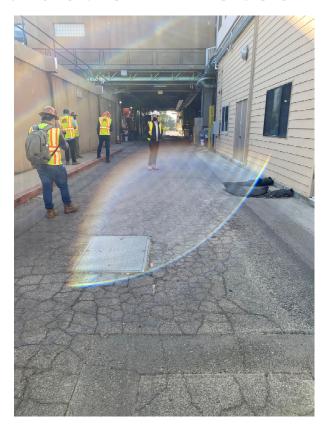
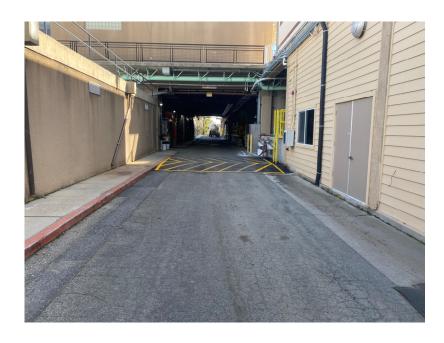
Containment Berm Work – Before and After

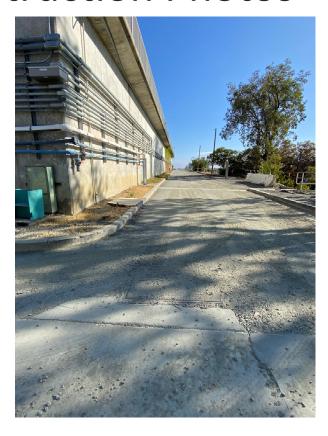
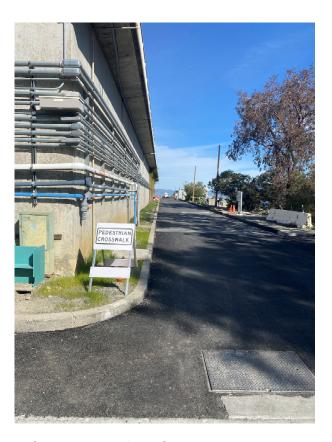
Paving By East Clearwell – Before and After

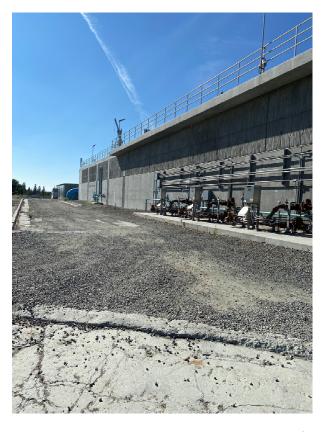
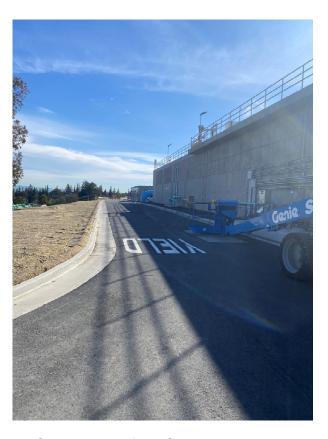
Paving By North Floc/Sed – Before and After

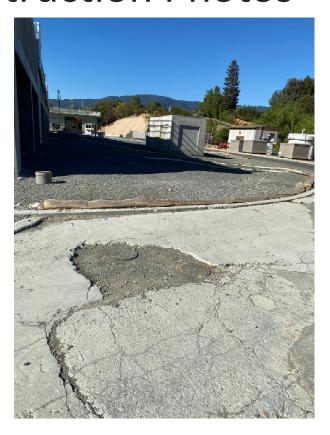
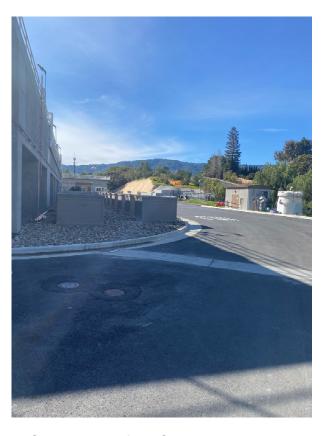
Paving By West Floc/Sed – Before and After

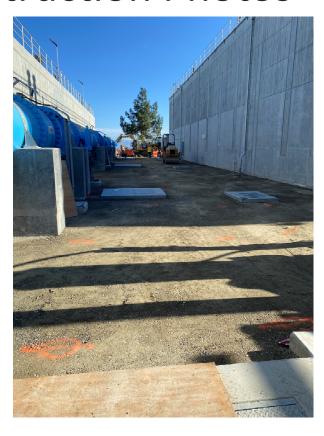
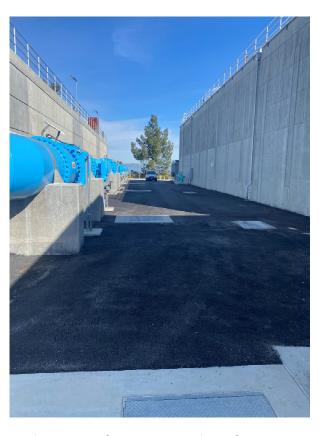
Paving Between Ozone and Floc/Sed – Before and After

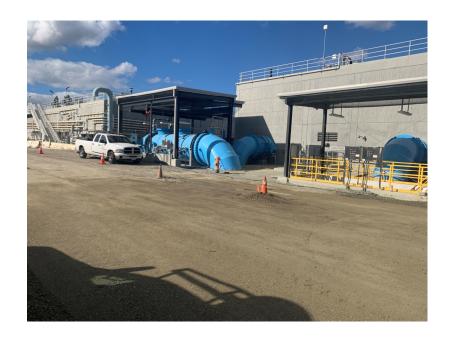
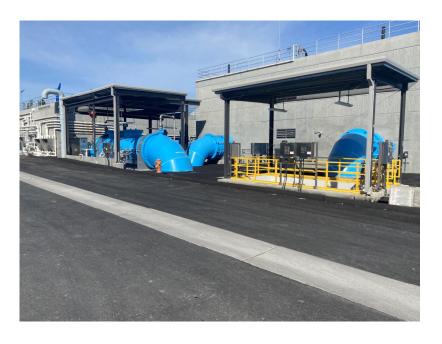
Paving South of Ozone Contactor Structure – Before and After
