MEMORANDUM

SUBJECT Emergency Declaration for Dam Repairs
Pursuant to Public Contract Code §22050:
Coyote Percolation Dam

DATE: August 21, 2017

Coyote Percolation Dam

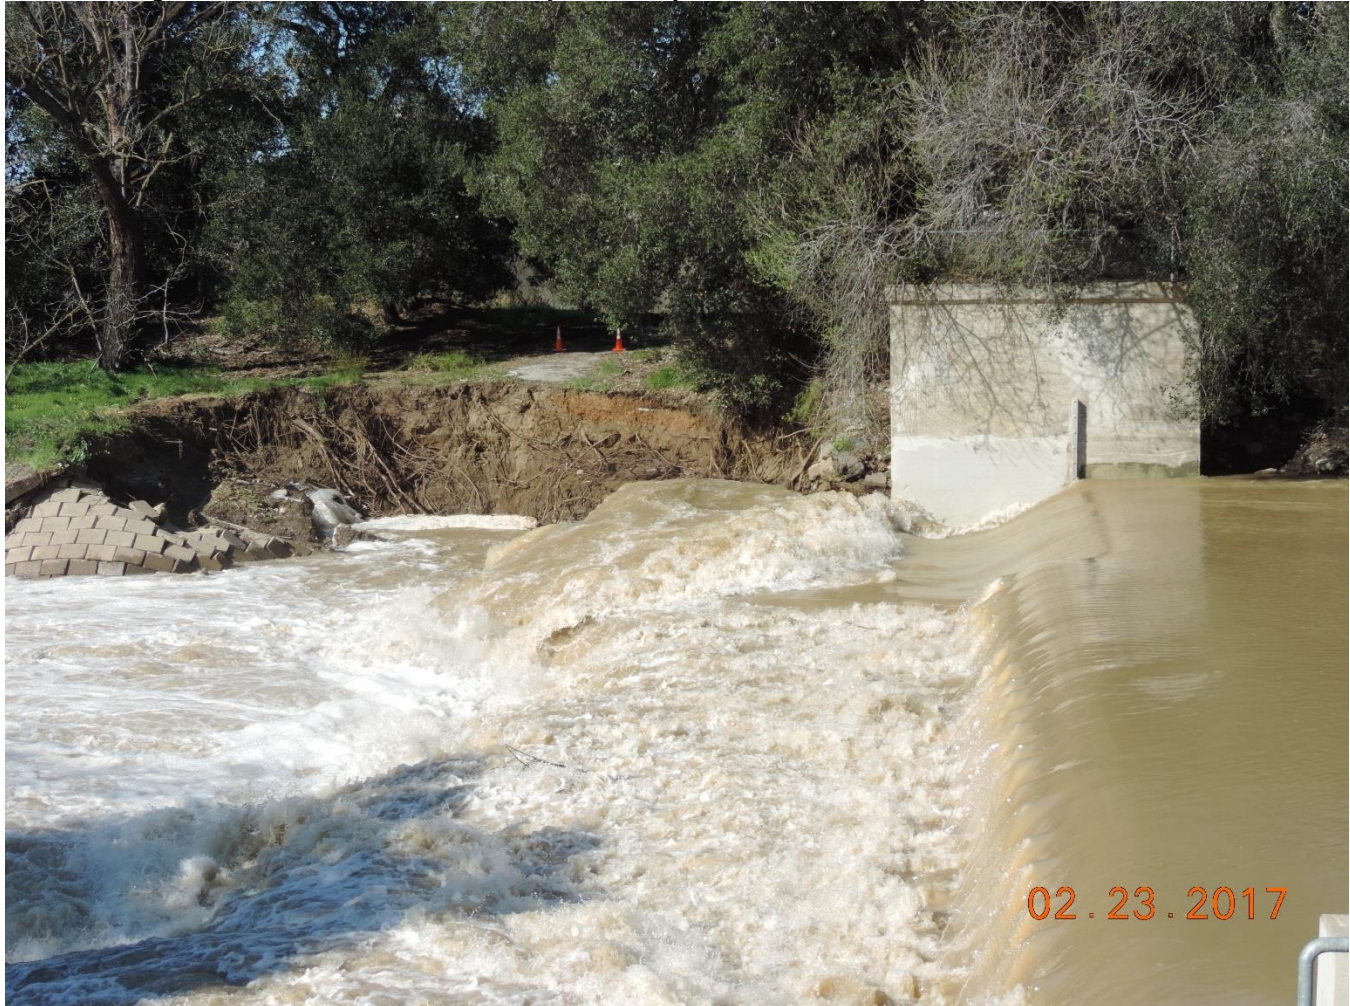
The storm flows on February 21-22, 2017, damaged the dam facility severely, in particular the dam apron suffered a scour hole that may extend 14 to 16 feet below the foundation. The exact extent of the damage is unknown because visibility is restricted by the concrete apron and the material beneath the apron.

Photo 1: High flows and erosion caused by February storms – February 2017

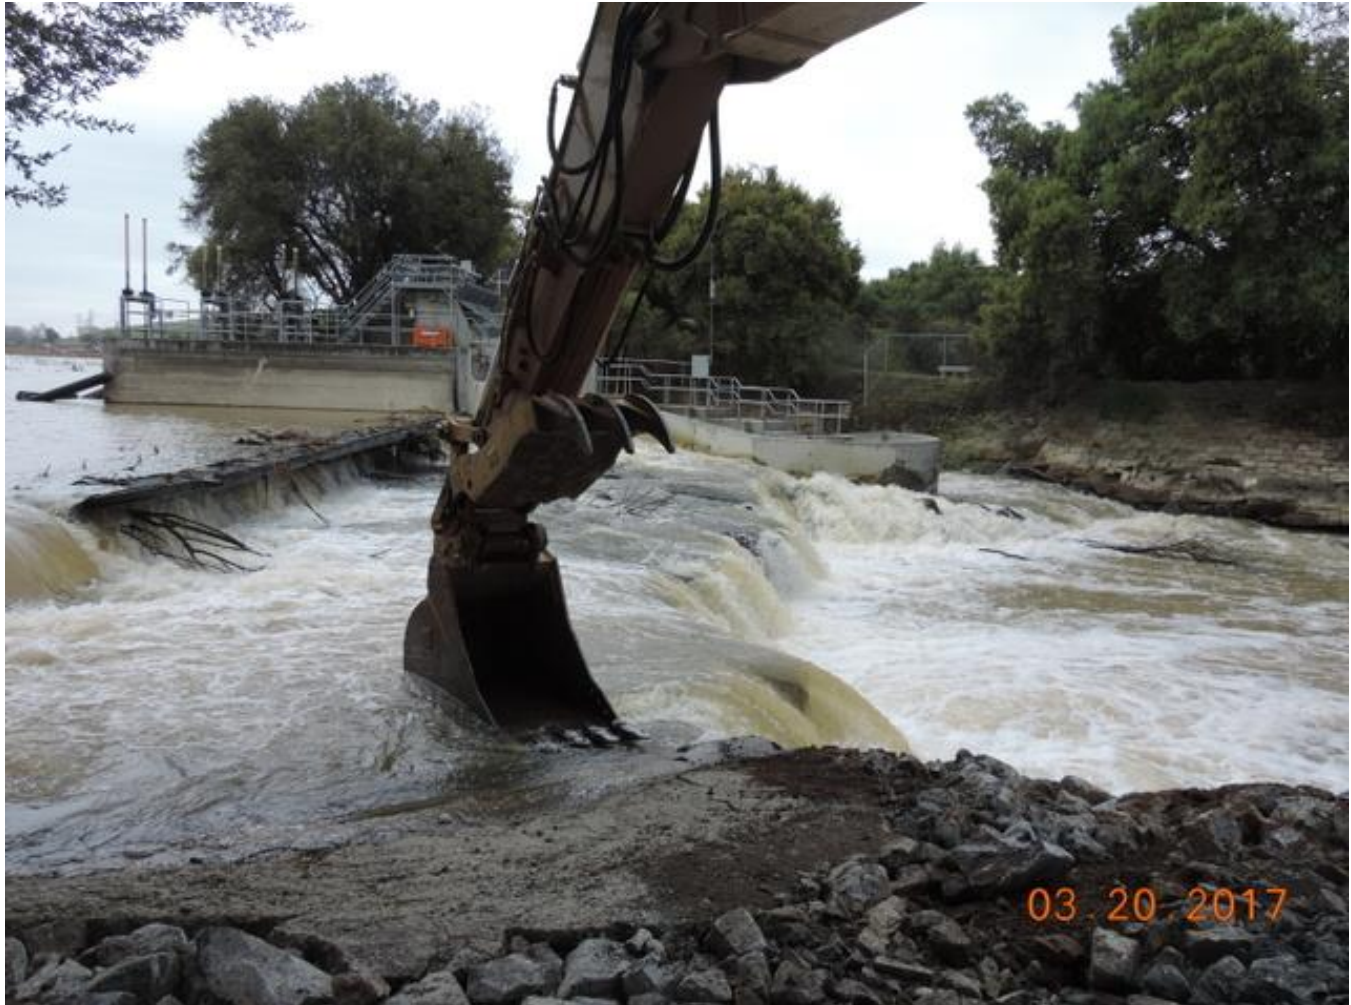
Under an emergency permit issued by the Army Corps of Engineers (File No. 2017-00166S/NWP 5, issued March 17, 2017), actions were taken to temporarily buttress the facility along the downstream side of the apron. Stabilization work was not completed as flows did not recede, and the emergency permit expired on April 1, 2017. The dam site remained inundated until the end of May as a result of required reservoir releases and tributary flows. DSOD conducted a visual inspection on May 8, 2017, but was unable to see the damage due to high flows and requested additional inspection of the apron and dam foundation prior to reinstallation of the steel panels.

Photo 2: Emergency work to buttress downstream side of dam – March 2017

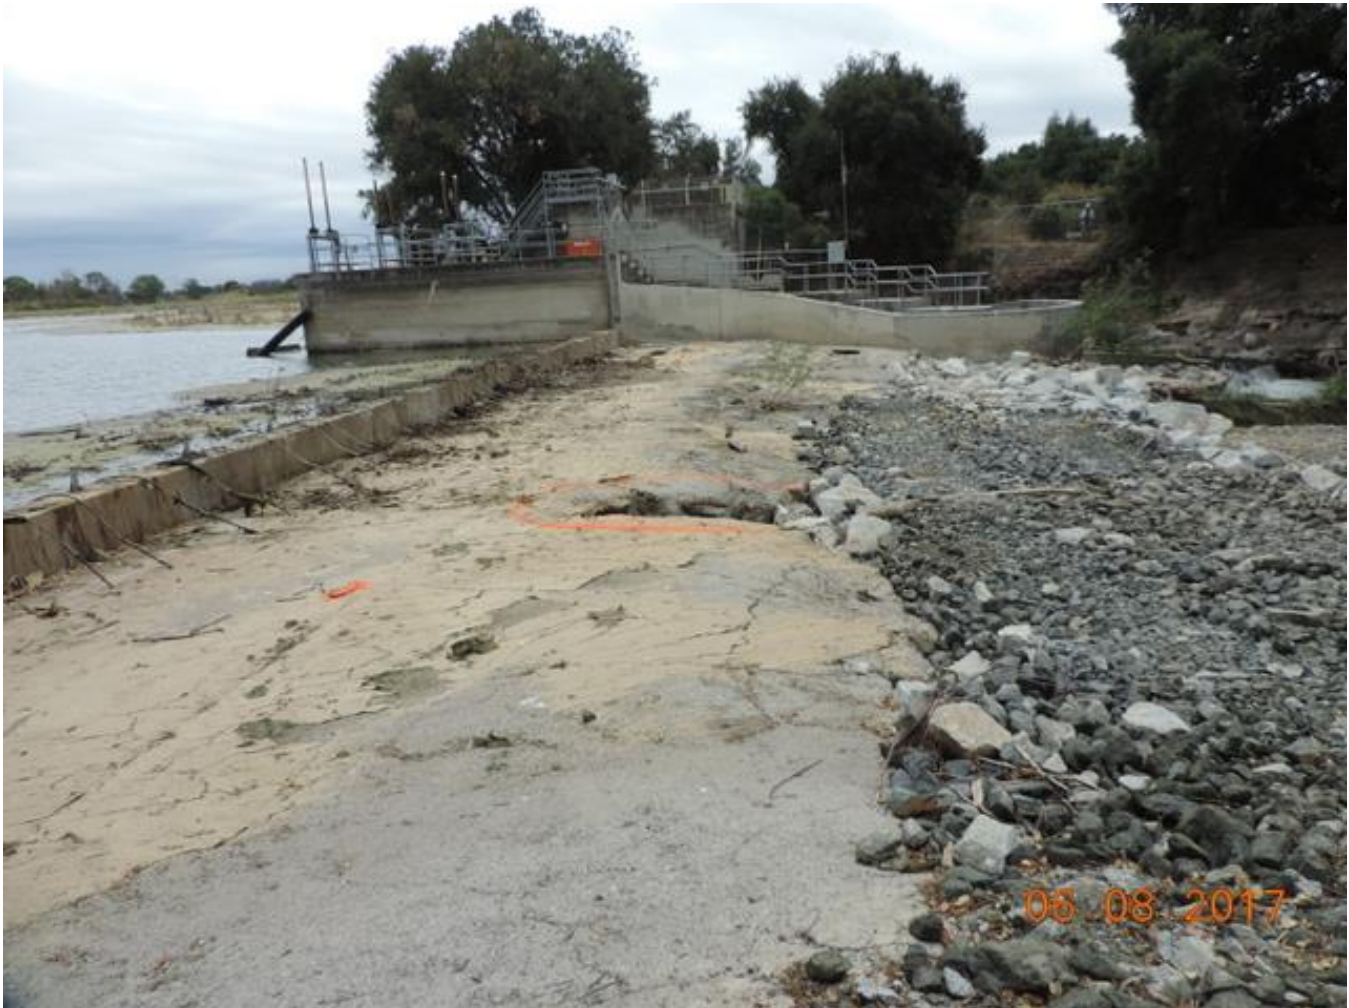
In June, flows receded enough to allow staff to evaluate the condition of the dam. It was determined that the dam apron structure was not likely to weather another winter of high flows in its current condition. Flows over the dam could continue to erode the apron and undermine the dam foundation ultimately leading to failure of the concrete structures. Should the structures fail, high flows could mobilize large amounts of sediment and concrete chunks, potentially damaging flood protection facilities and blocking flows -- for example by jamming against bridge abutments -- leading to flooding.

Photo 3: Dewatered site showing damaged apron and downstream buttress – June 2017

There is not adequate time to complete a formal competitive bidding process for the work and complete the required repairs before the start of the rain season (October 15). Staff must immediately begin working with a qualified contractor to initiate the work as soon as possible to allow time for DSOD to inspect the facility and the District's contractor to complete repairs prior to the rain season. The inspection by DSOD will be scheduled during the repair work when the District excavates the concrete apron. The dam's foundation will be evaluated and the concrete apron replaced in a manner approved by DSOD to protect the facility from future high flow events.
