Almaden Valley Pipeline Inspection and Rehabilitation Project Update

Jim Crowley, Engineering Unit Manager
Barton Ching, Associate Civil Engineer
Katrina Jessop, Associate Civil Engineer

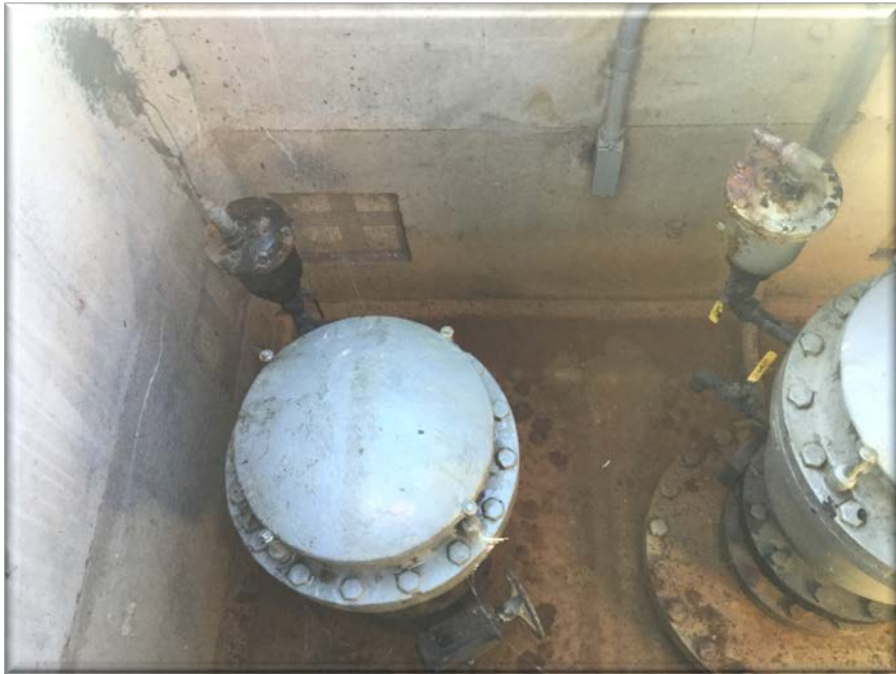
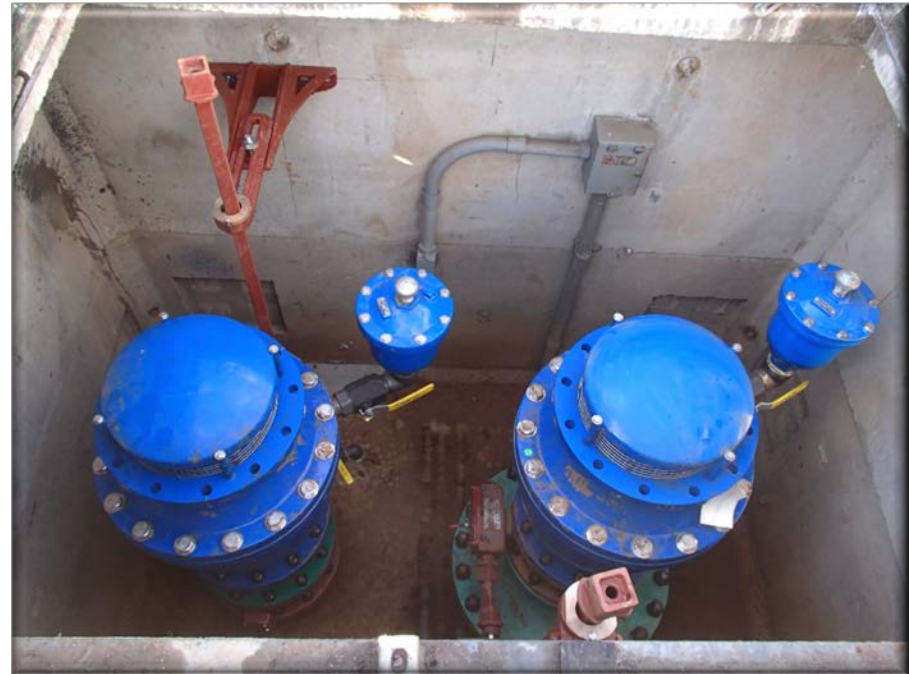
Appurtenance Vault Rehabilitation

Typical of 93 vaults along the Almaden Valley Pipeline
