ALMADEN VALLEY PIPELINE EMERGENCY RESPONSE SUPPORT PROJECT

Notice of Completion of Construction Contract

April 9, 2019

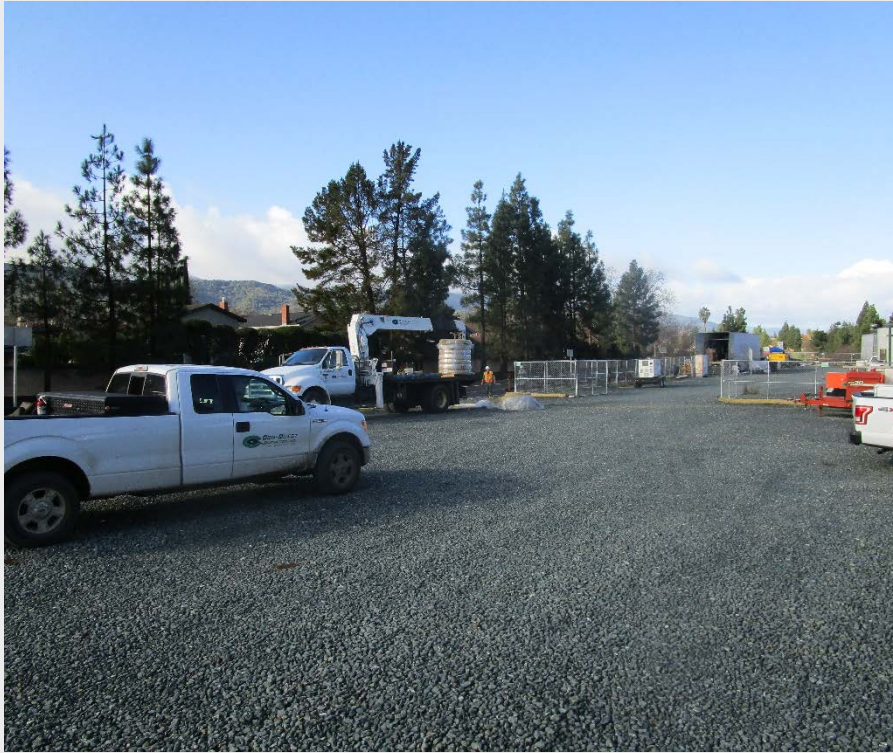
Establishing staging area.

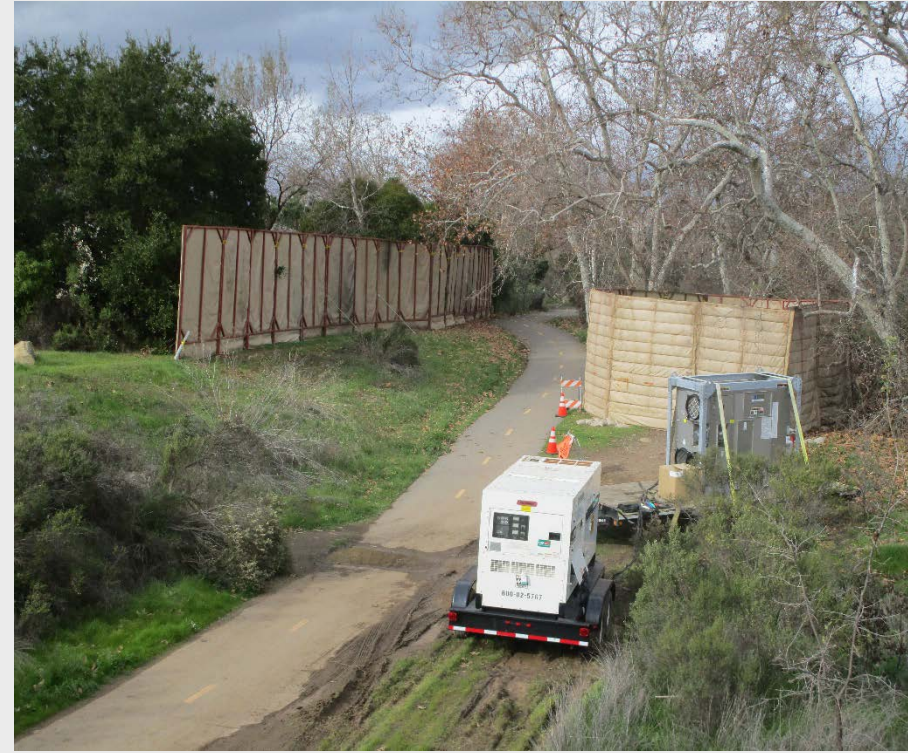
Installation of sound panels and temporary power.

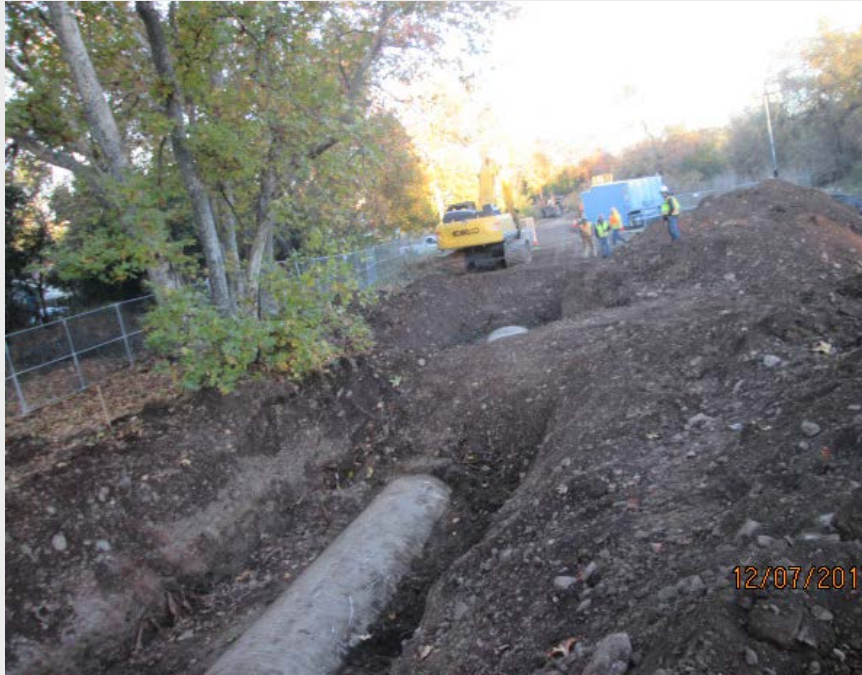
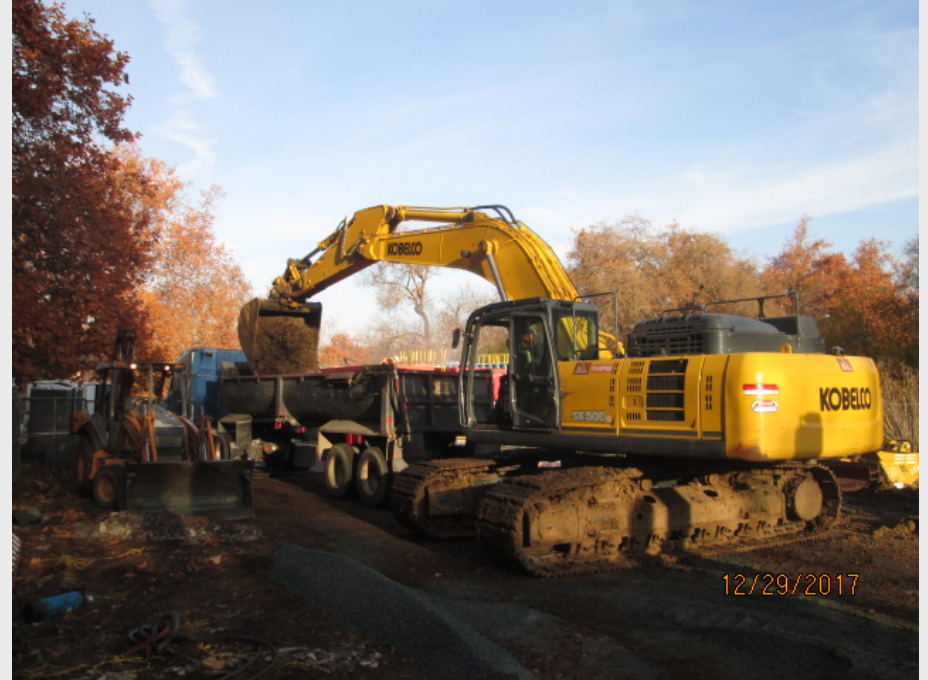
Exploratory excavation to expose buried pipe sections along AVP.

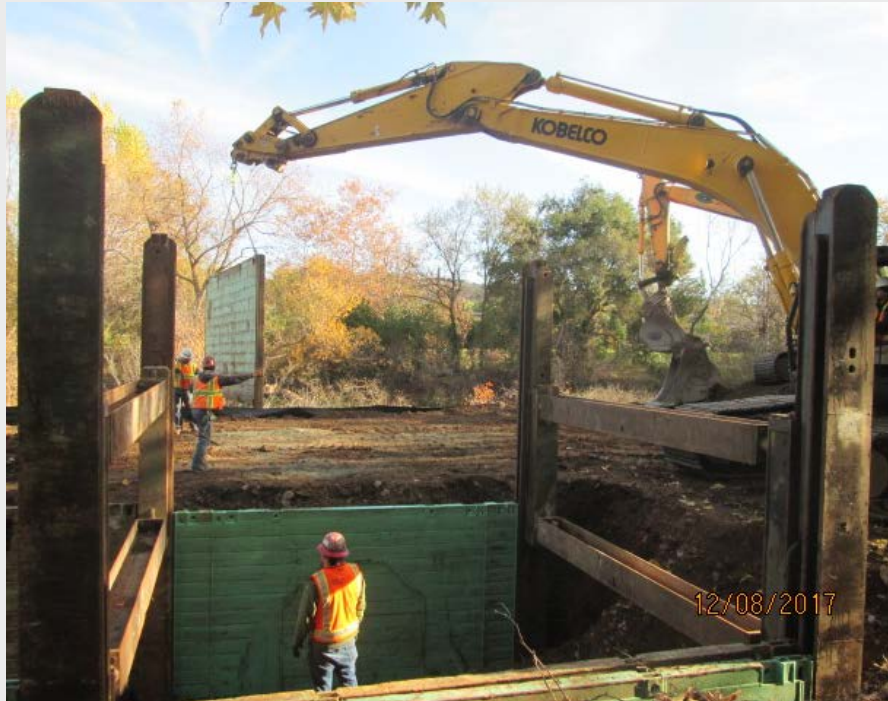
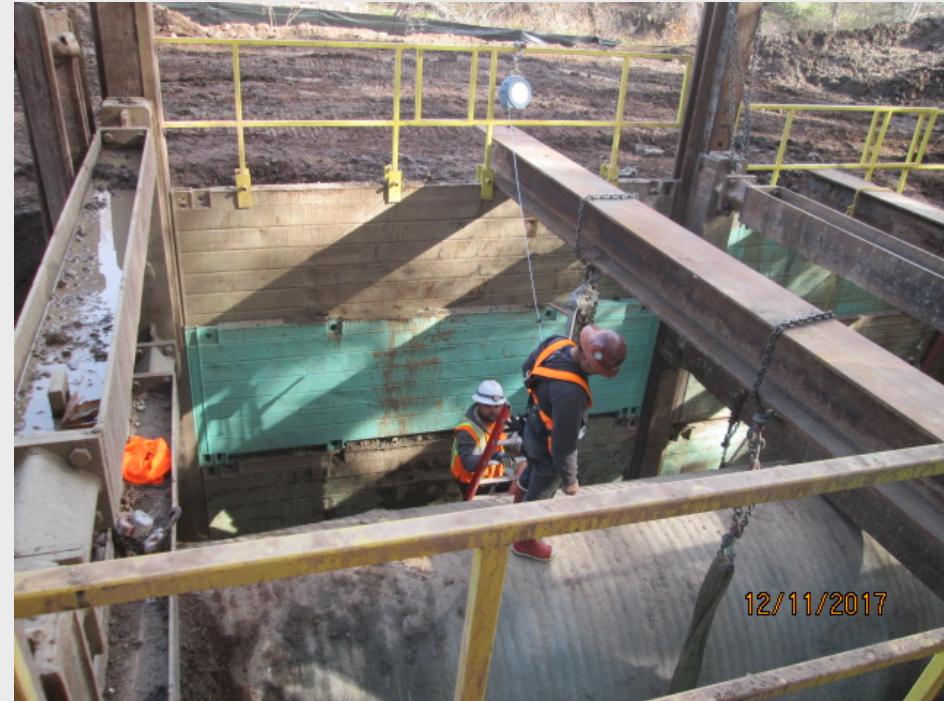
Installation of shoring system for external pipe repair on AVP.

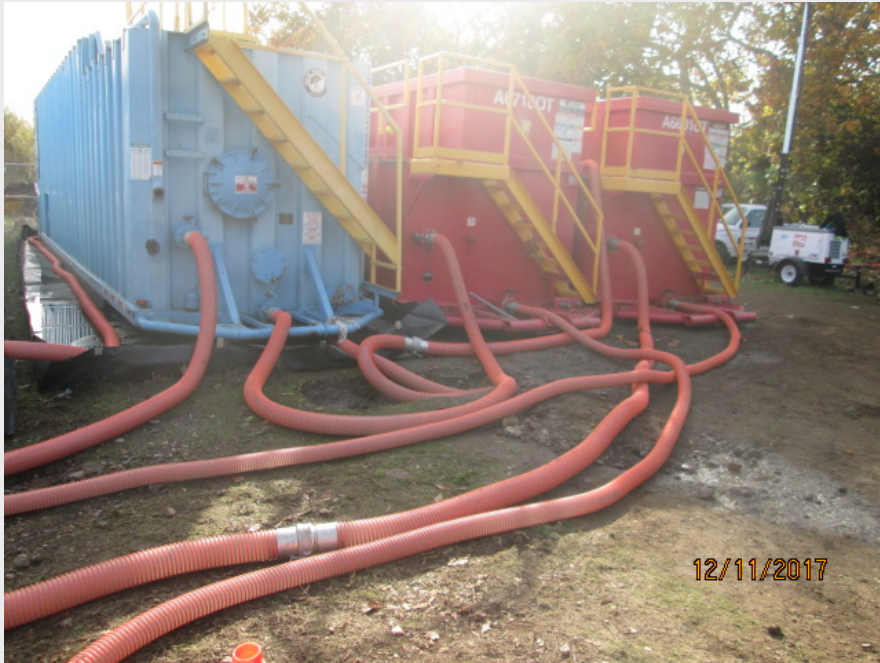
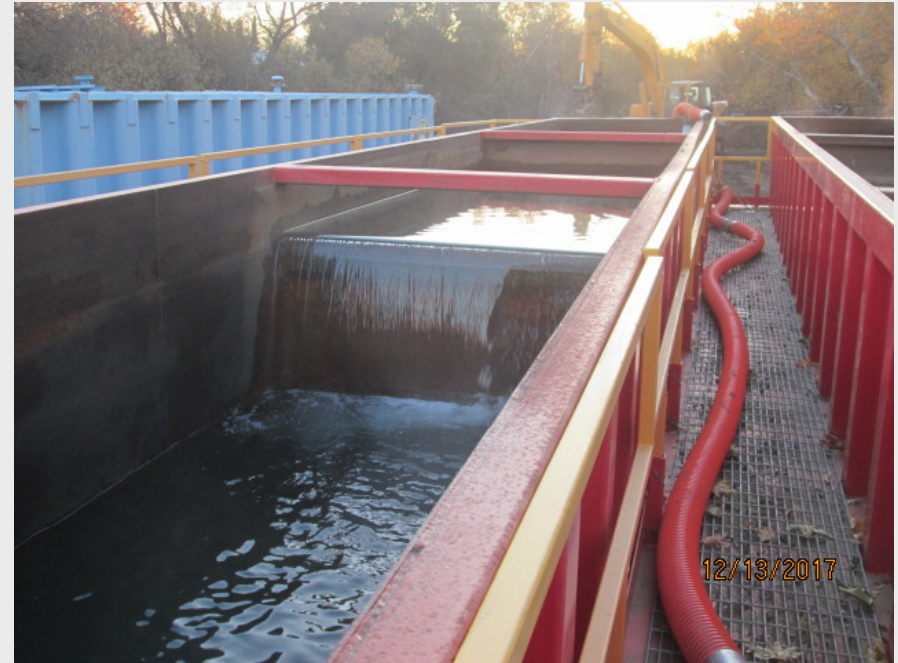
Installation of water desilting tanks for dewatering operations.

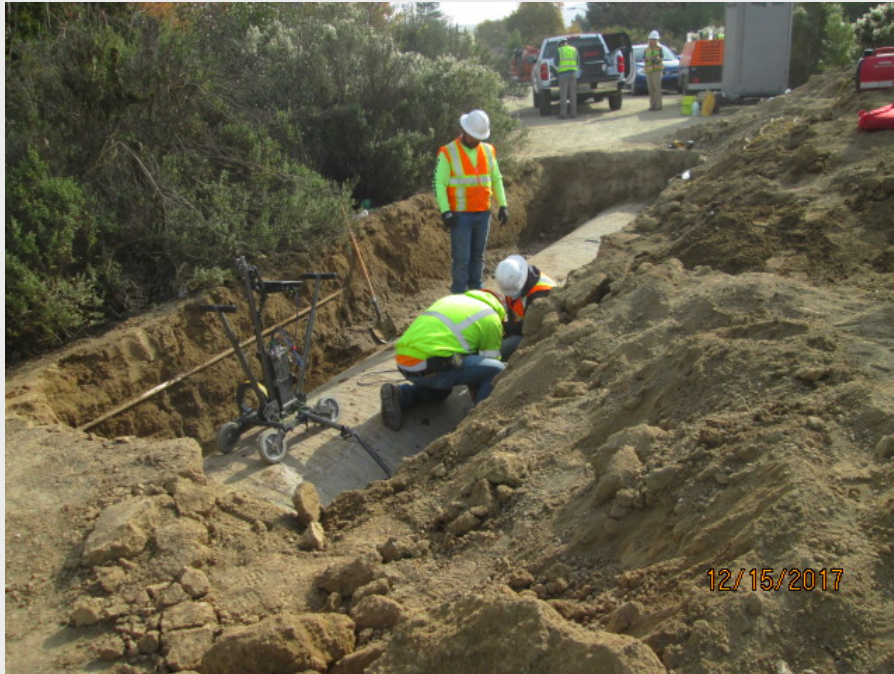
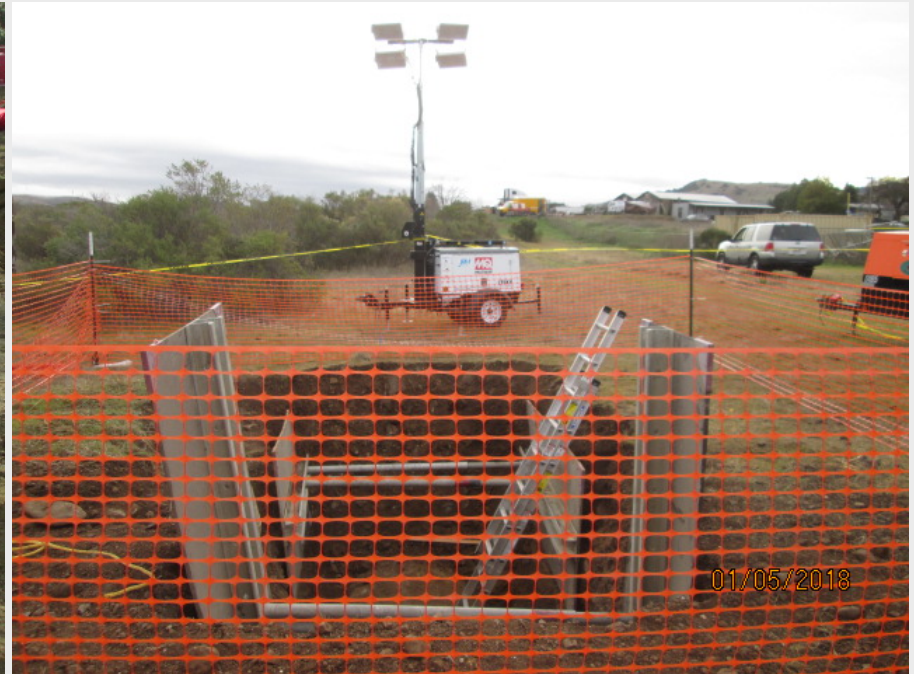
Additional exploratory excavation along different pipe segments of AVP.
