Structural Damage Assessment

EFI Global File No.: 024.02873
February 2, 2021

Reference: Drake residence
2095 Morrison Avenue
Santa Clara, CA 95051

Date of Loss: October 28, 2020

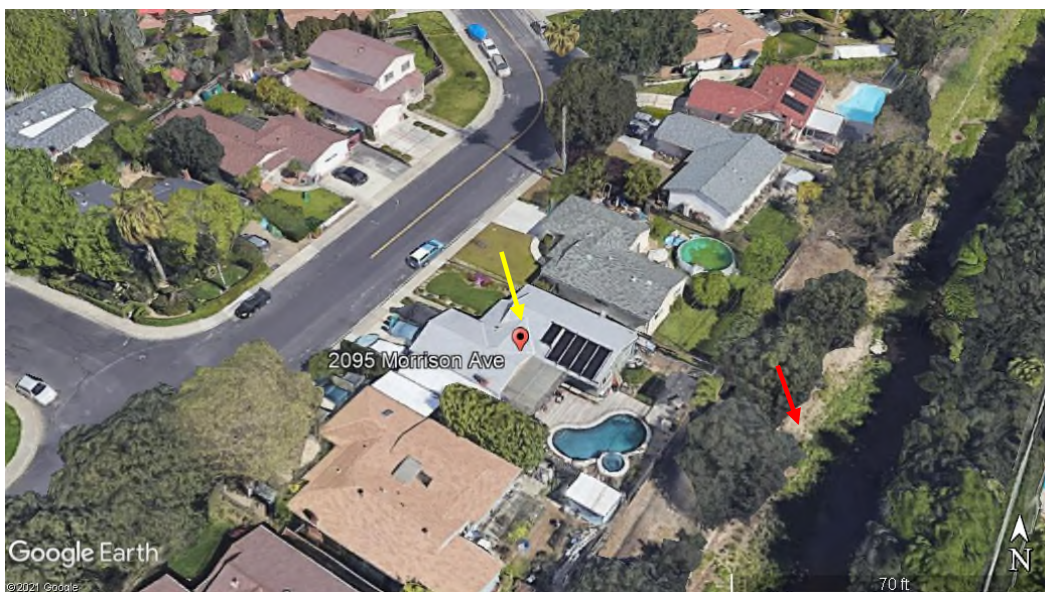
Photo No. 1: The claimant's home (yellow) with the pool that was almost 30' from the improved gravel roadway between the home and the bottom of the canal (red).

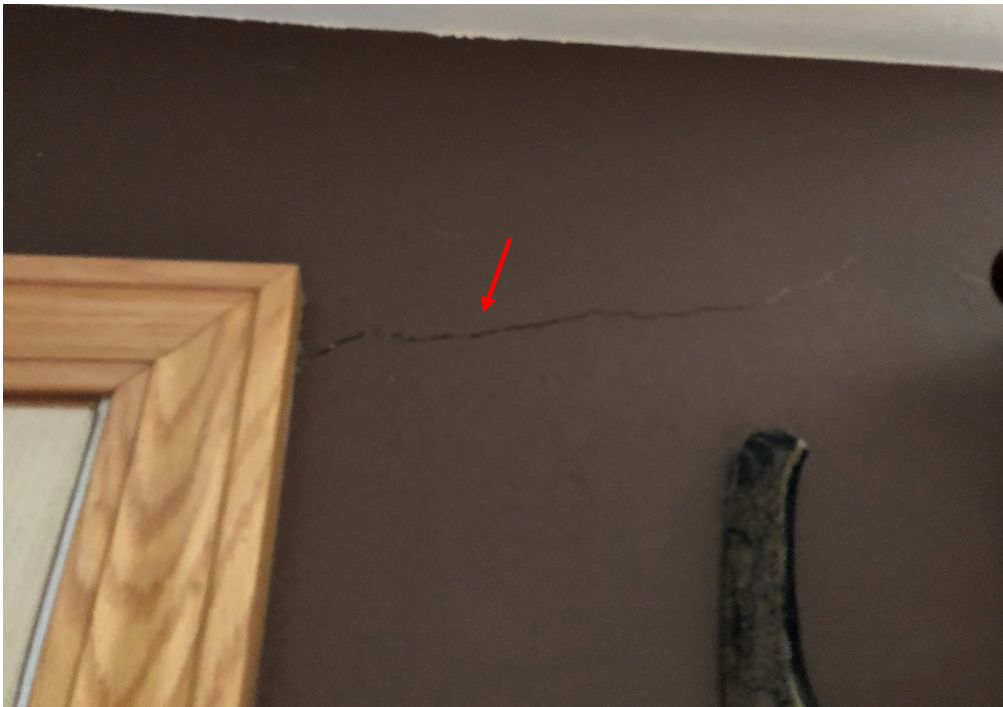
- The front door was operating properly though the claimant reported ongoing issues with the door. Another door was also operating properly though repairs were required twice recently on both doors. (Photo 3)
- There were newer appearing cracks in wall drywall at multiple locations throughout the home. At one window, the frame was separating. (Photos 4-6)
- There were several other drywall cracks in the walls and ceilings of the home. These were reported as existing for a long duration, and before the insured's work in the adjacent creek.

Photo No. 4: There were newer appearing cracks in wall drywall at multiple locations throughout the home.

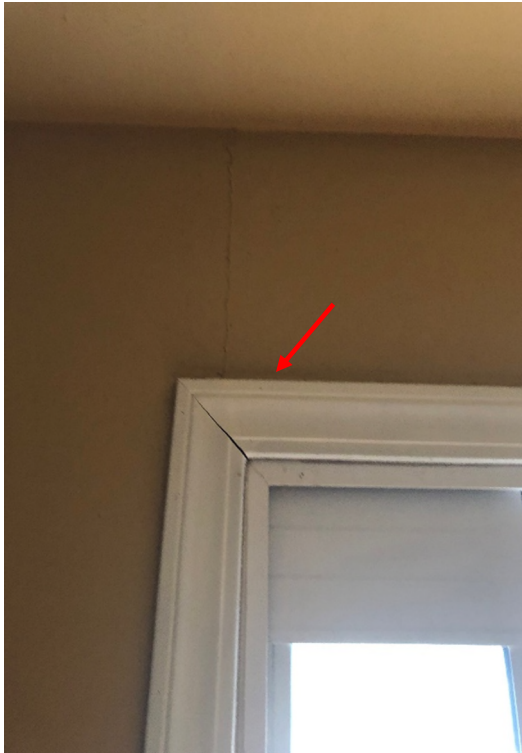
Photo No. 6: Wall drywall was cracked, and the window frame was separating.

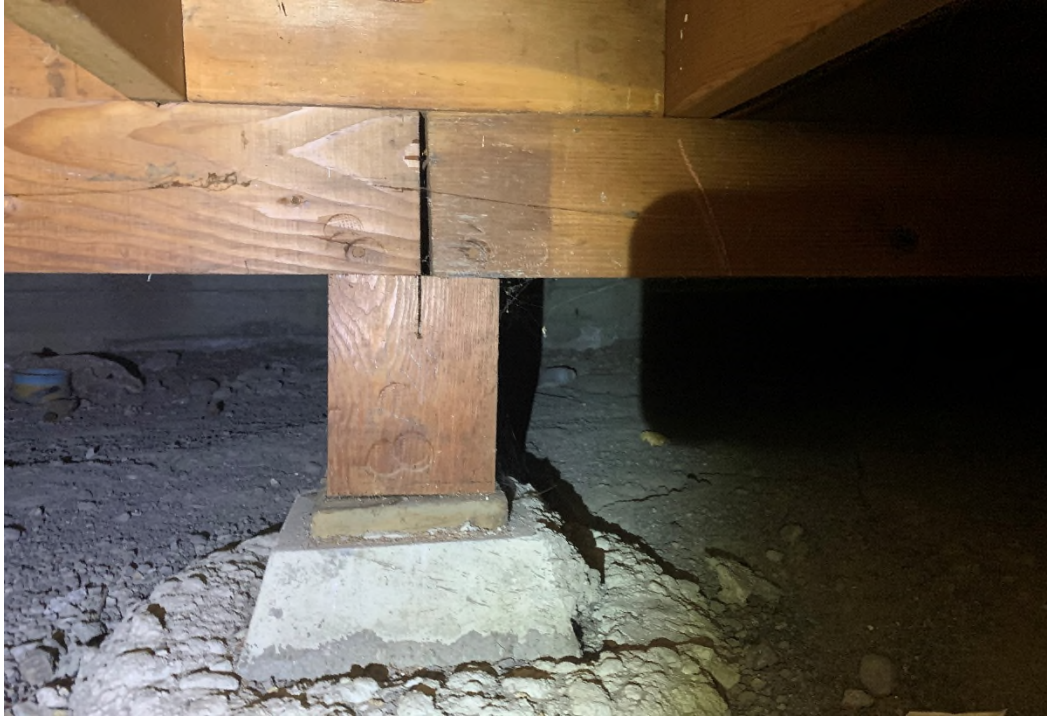
- Below the home, the floor framing inadequately connected to each other. Beams only lapped partially onto posts and fastened to the posts with a couple of toenails. Posts were toenailed to the wood bases of the concrete pier foundations. Below the kitchen, there was evidence of prior or current moisture exposure damage to framing and sheathing. A beam was visibly deflecting (red) along its span at this location. Throughout the crawl space, concrete pier foundations had settled differentially into the soil substrate. Posts were not plumb. Joists were not adequately connected to beams and were unrestrained against rotation. Large desiccation cracks indicated the presence of a clay element in the soils underlying the home. (Photos 7-9, 18)

Photo No. 7: Below the home, the crawl space revealed floor framing inadequately connected to each other. Beams only lapped partially onto posts and fastened to the posts with a couple of toenails.

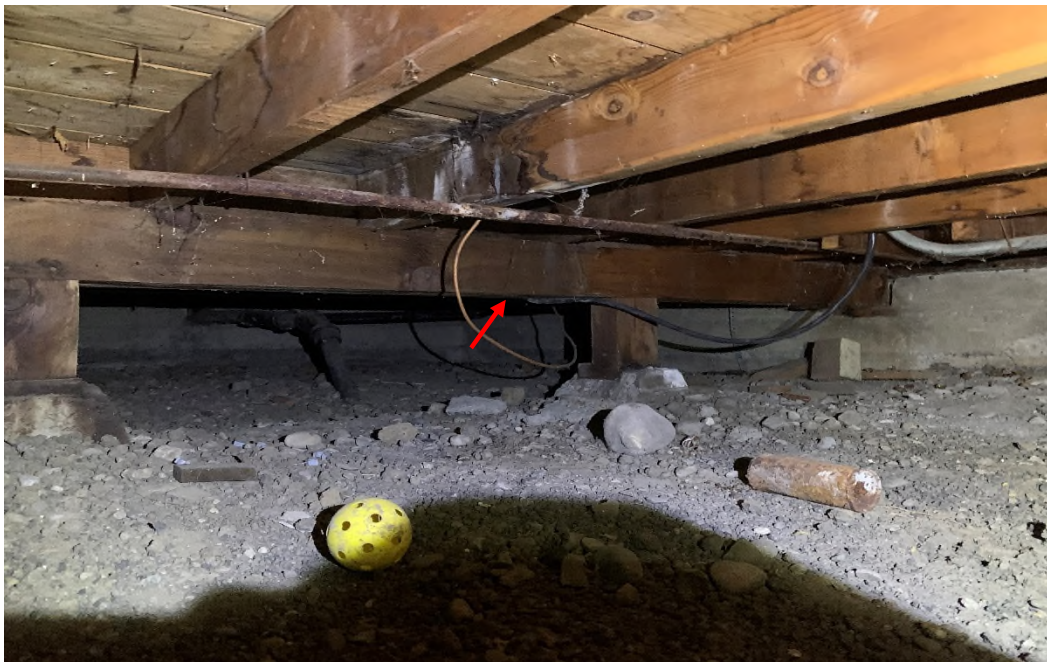
Photo No. 8: Below the kitchen, there was evidence of prior or current moisture exposure damage to framing and sheathing. The beam was visibly deflecting (red) along its span.

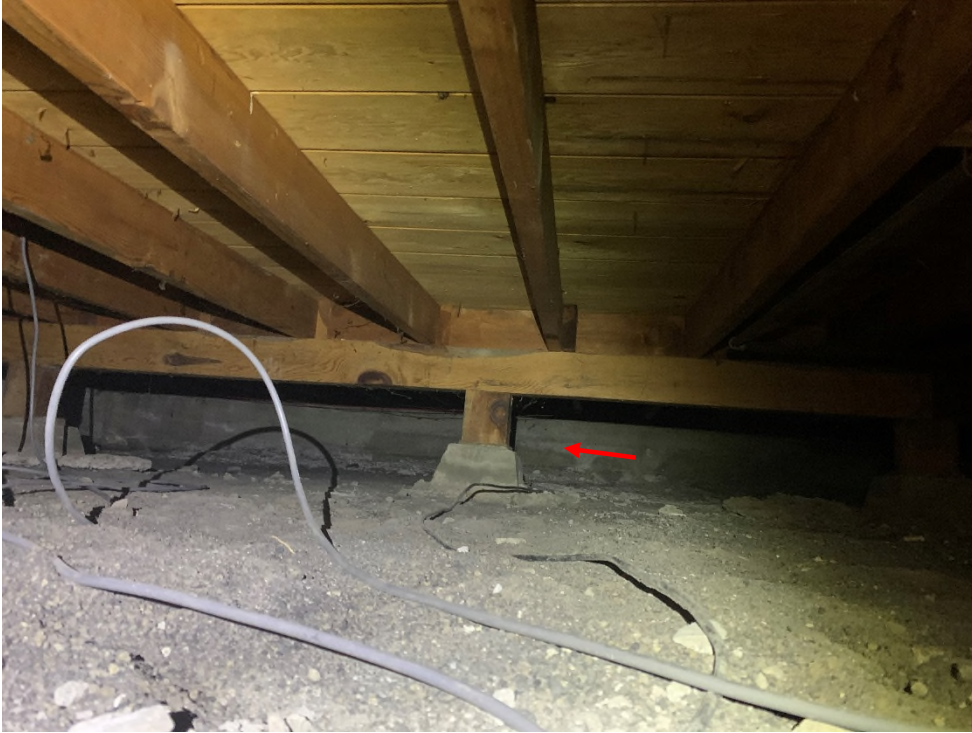
Photo No. 9: Concrete pier foundations had settled differentially into soil substrate. Posts were not plumb. Joists were not adequately connected to beams and unrestrained from rotation.

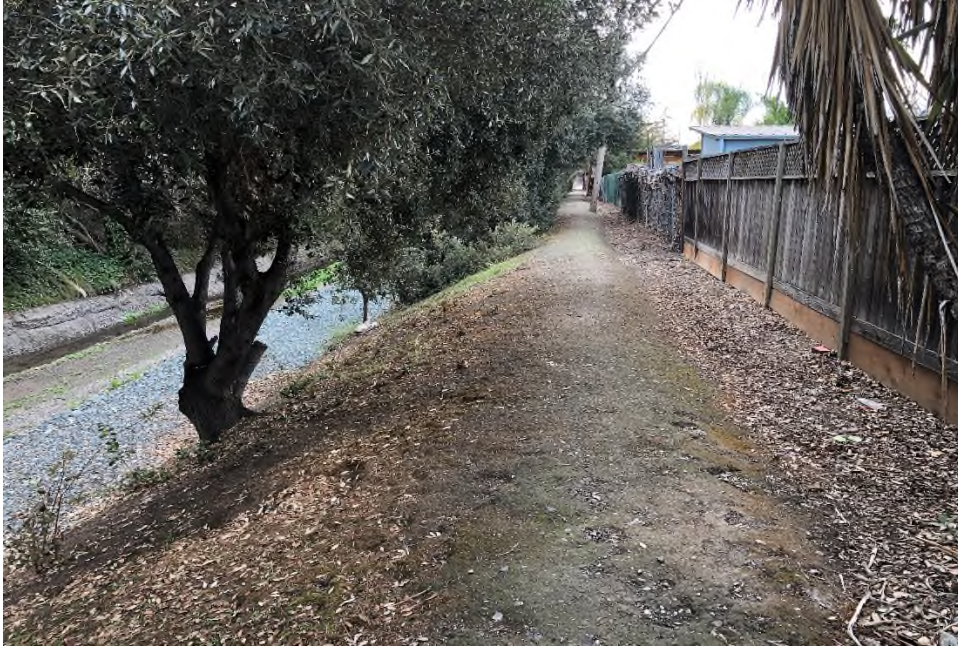
Photo No. 11: Looking south behind the claimant's home. A gate in the claimant's east fence accessed a pedestrian pathway, the creek bank, the improved gravel roadway, and the creek bottom.

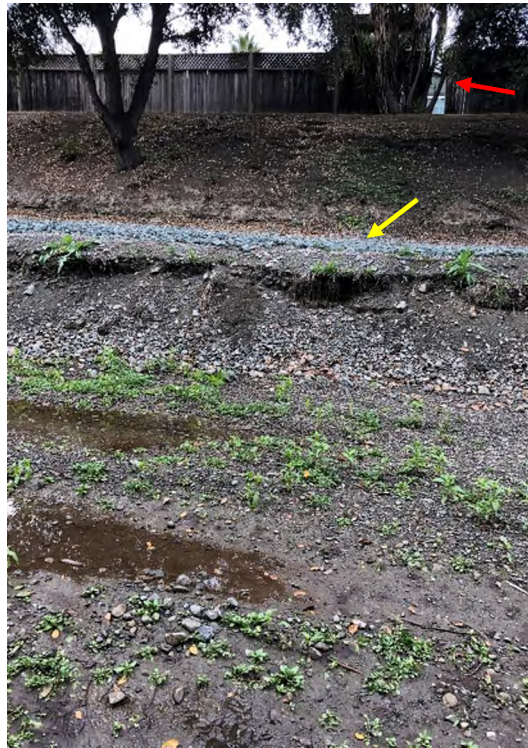
Photo No. 12: In the creek looking west at the claimant's east fence and open gate (red). The creek flowline and profile were apparently re-established through excavation and the roadway (yellow) was improved.

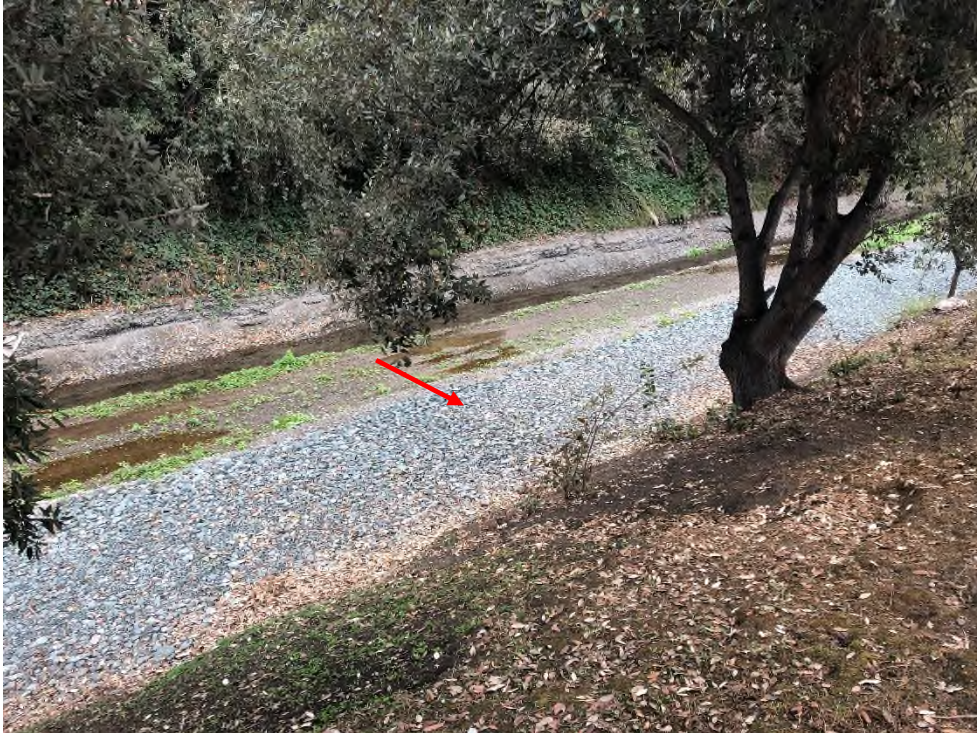
Road improvement and/or road construction typically involves the use of a vibratory sheepsfoot roller. This machine can be felt at significant distances laterally from the machines operating position. In this case, a smaller unit was likely employed due to the limitations of the available roadway width. The claimant interviewed neighbors of homes along the street, including those with nearby pools, and reported that nobody had sustained damage as a result of the insured's creek work. The damage to the claimant's pool was not in the deep end nearest to the gravel roadway both in lateral proximity and elevation. The damage was in the shallow end beyond the hot tub in a landscape area next to the skimmer which generates traffic and moisture behind the pool wall. It was an unlikely location to become damaged as a result of operations within the creek.

Photo No. 13: The gravel roadway (red), improved with heavy equipment including a vibratory sheepfoot roller, was almost 30' east of the claimant's pool. The gravel roadway was over 10' below the top of the bank.

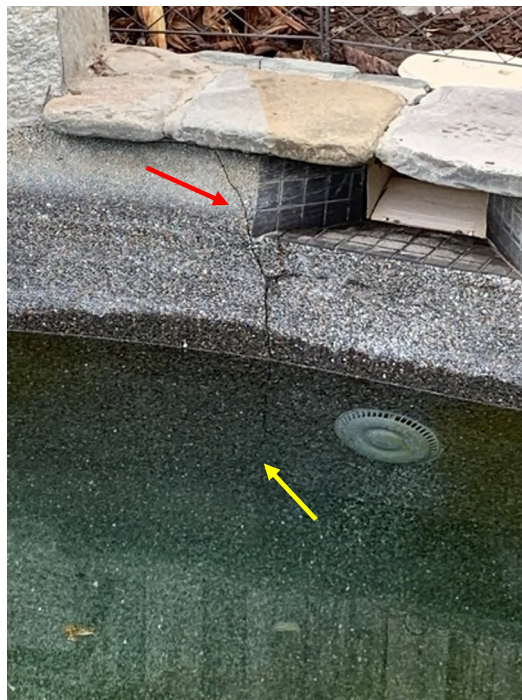
5. The moisture source was from storm precipitation and landscape irrigation water.
6. The crack in the pool wall in the shallow end was likely not associated or consistent with the insured's work in the creek. The crack was more likely the result of differential pool wall movements from underlying soil movements.

7. The soil movements were from changing soil moisture contents along with annual expansive soil movements previously mentioned. The crack location associated with moist landscape conditions behind the wall compared with the adjacent transition to hardscape concrete walkway/patio cover along the west and north sides of the pool.

Photo No. 14: The pool was cracked in the shallow end. The crack extended several feet down the wall.

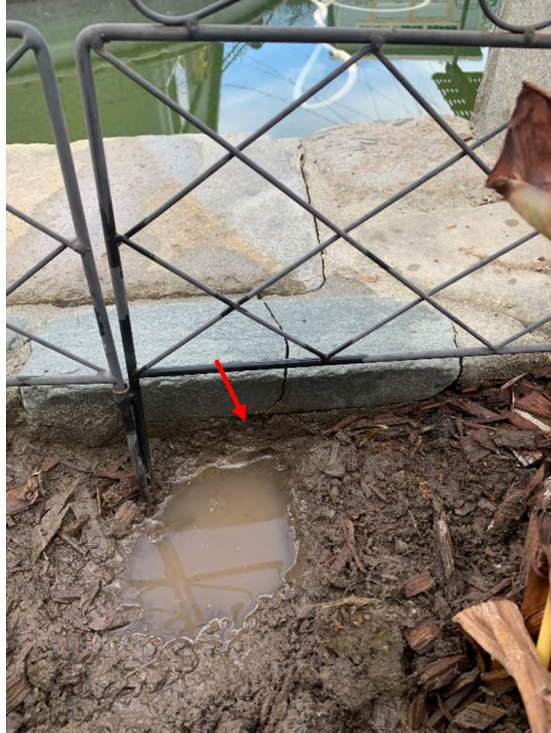
Photo No. 15: The crack continued across the top and back side of the pool wall. The water behind the pool wasn't a leak as some water was used to clean the concrete and expose the crack (red).

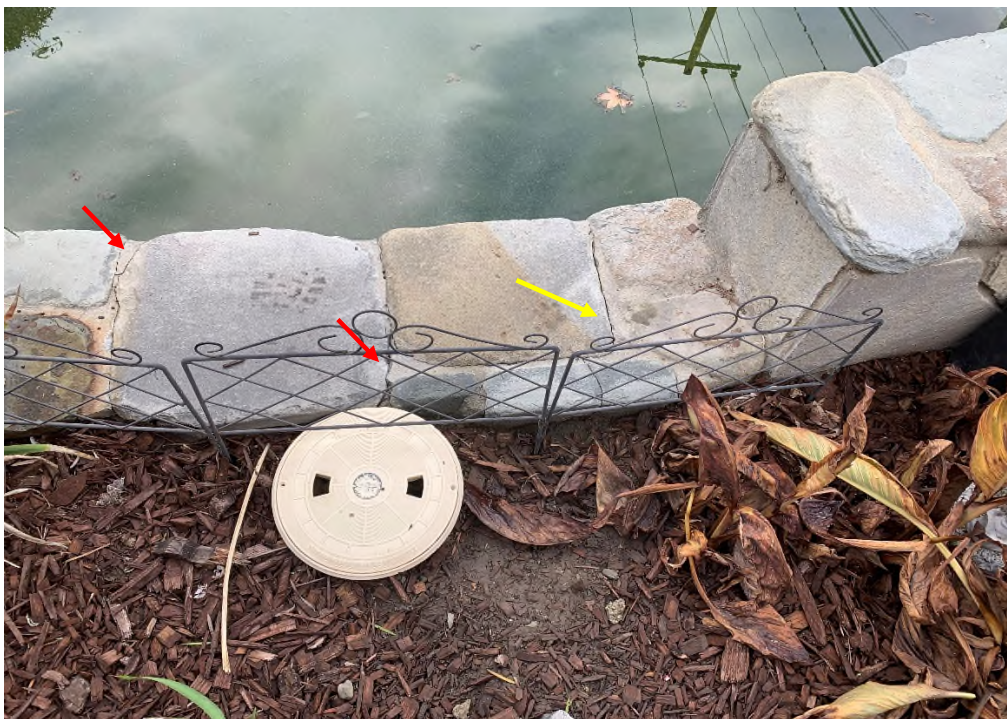
Photo No. 16: There were other cracks in the stonework besides the subject crack leading to the pool wall (yellow).

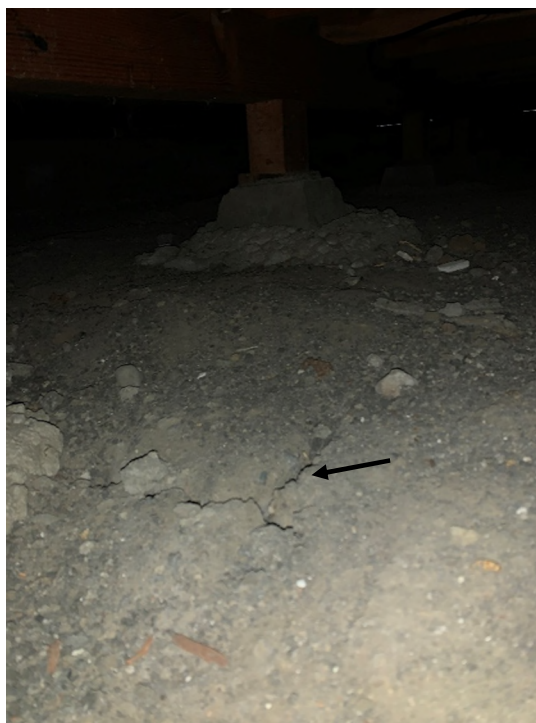
From the visible desiccation cracks in the crawl space, and from the exposed soils in the recently excavated creek profile, there was the presence of clay in the soils confirmed with a field test during this inspection. The expansive nature of clayey soils, along with the annual swelling and shrinkage of the soils likely resulted in soil movements underlying the home's foundation. The sunken and/or differentially settled pier foundations and resulting out of plumb posts were likely the result of soil movements that caused the foundations to move. The nature of the damage in home involved existing cracks and newer developing cracks in the wall and ceiling drywall. Repairs to various doors were ongoing as a result of ongoing movements of the foundation, floor, and wall elements. The ongoing and gradual nature of the damages described were consistent with soil movements in expansive soils more than from work in the creek over a short duration. The issues described continued to be occurring well after the creek work completed.

Photo No. 18: Large desiccation cracks in the crawl space soils indicated the presence of a clay element in the soils underlying the home.
