Valley Water

Almaden Valley Pipeline Condition Update

Presented by: Raw Water Division

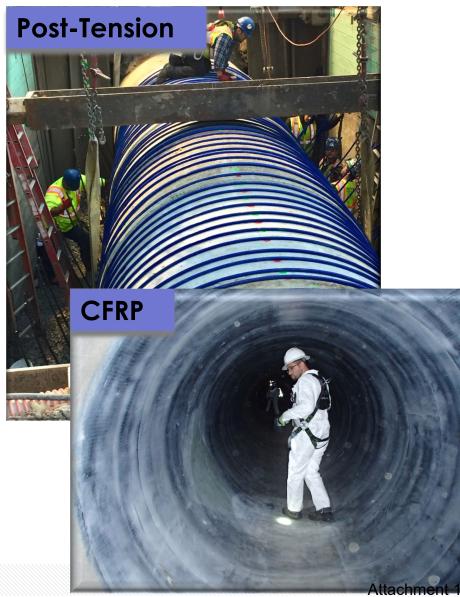
- Procure PCCP Monitoring and Condition Assessment Technology (Apr. 2017)
- Inspection and Rehabilitation Project (Sept. 2017)
 - Hydrogen Embrittlement
- Emergency Repair (Dec. 2017)
 - 81 PCCP Pieces
- Emergency Repair (Dec. 2019)
 - 5 PCCP Pieces

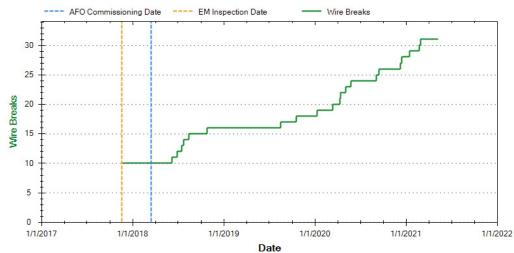
AFO Monitoring Indicates PCCP Pieces Continue to Degrade.

PCCP Pieces Approaching Severely Distressed
Conditions per Finite
Element Modeling.
