Project F1: Vegetation Control and Sediment Removal for Capacity Supplemental information to the Management Response to IMC Recommendations

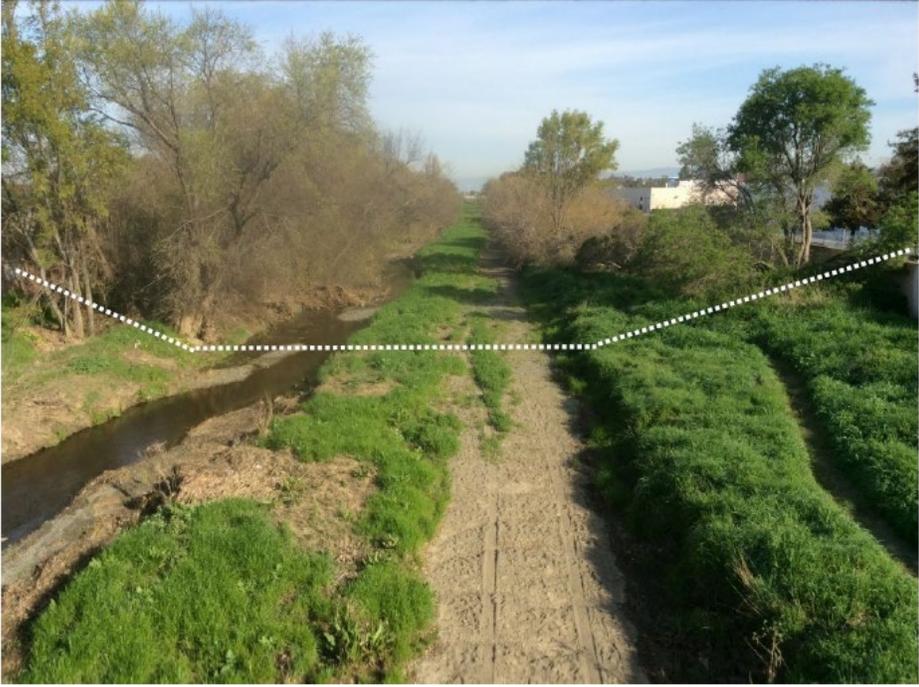
Figure 3: Example Stream Maintenance Guideline Representative Cross-Section Photo (2015) for Calabazas Creek, Reach 1c

Figure 3 is a 2015 photo of the representative cross-section of this reach of Calabazas Creek. Based on staff observations and referencing a roughness/vegetation photo atlas developed for use on county streams, a composite roughness of 0.042 was ascribed for this site.

Calabazas Creek Reach 1c	Composite Roughness: 0.042
Date: Spring, 2015

<p>Estimated vegetation composition (dotted cross-section):</p> <p>Grasses = 30%</p> <p>Herbaceous = 30%</p> <p>Woody = 20%</p> <p>Bare ground & water = 20%</p>

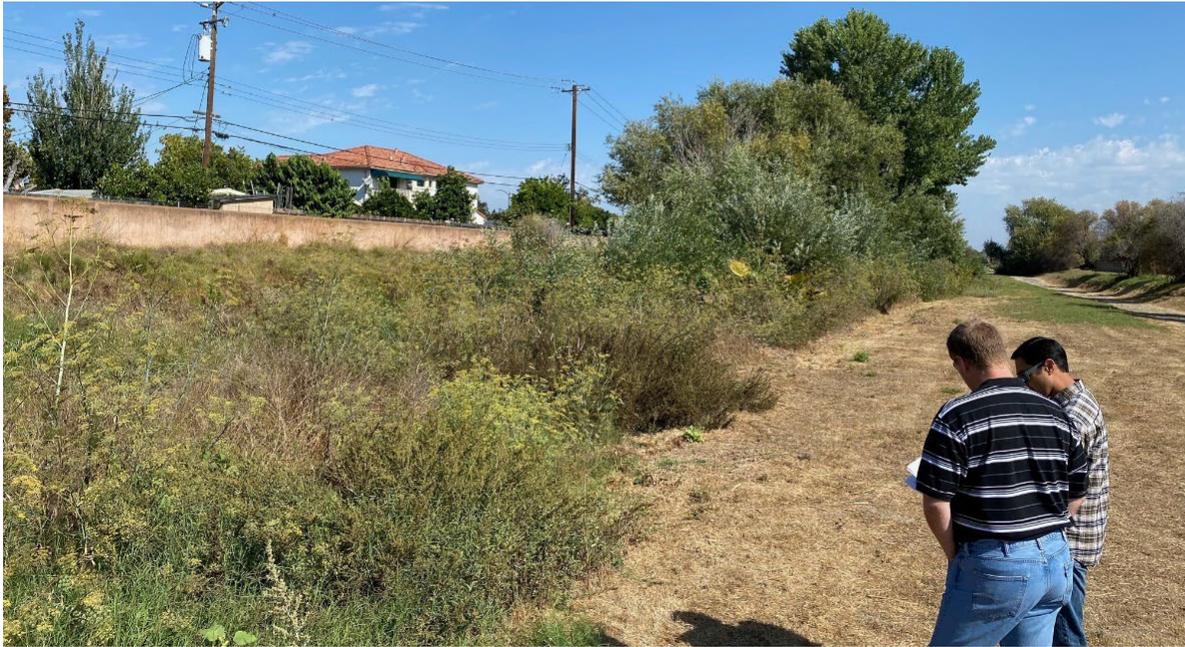
Figure 4: Example Stream Maintenance Guideline Photo (2022) for Calabazas Creek, Reach 1c

Figure 4 is an August 2022 photo from the same reach. As compared to the photo in Figure 3, the Figure 4 photo indicates much more vegetation has grown in this reach, and while it may not be readily apparent, sediment accumulation has occurred as well. Based on staff's observations, a composite hydraulic roughness of 0.05 to 0.055 was estimated.

Taking the above information into account, with an estimated composite roughness of 0.05 to 0.055 and observed minor sediment accumulation, as depicted by the blue circle in Figure 6, it can be concluded that maintenance is recommended in this reach of Calabazas Creek.

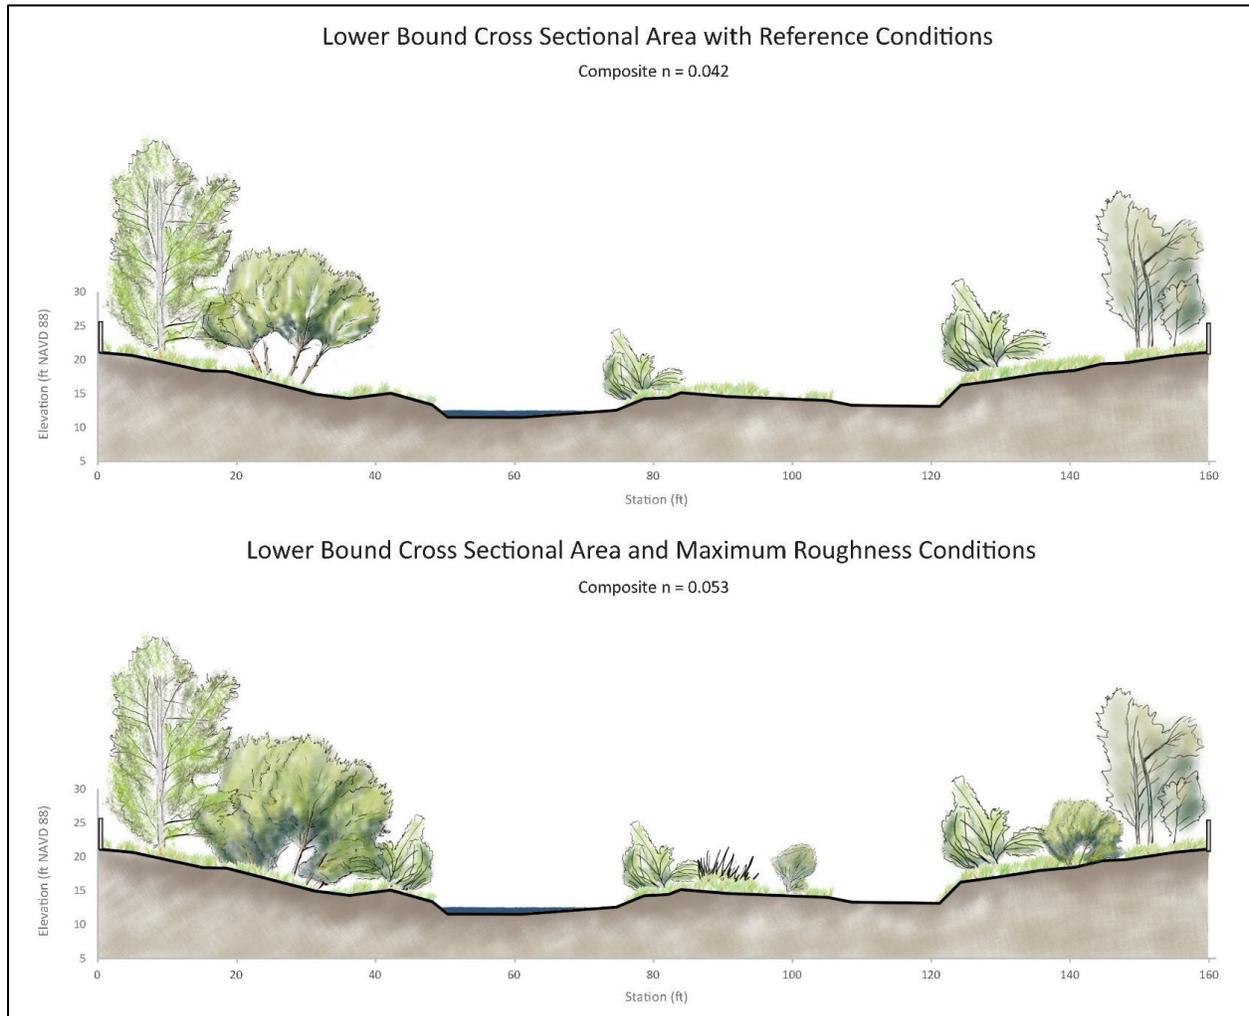
Figure 5: Example Stream Maintenance Guideline, Representative Roughness Cross-Section for Calabazas Creek, Reach 1c

Figure 5 illustrates the representative roughness cross-section for this reach. To provide a visual comparison of conditions, this figure includes two depictions of the representative section:

- The upper cross-section portrays roughness characteristics under observed conditions in 2015.
- The lower cross-section portrays the maximum roughness evaluated as part of the analysis. This lower cross-section more closely resembles what was observed in 2022.
