Coyote Creek- Locations with < 100 Year Capacity

Coyote Creek- Channel Capacity and Description of Flooding which would occur shortly after channel capacity exceeded.

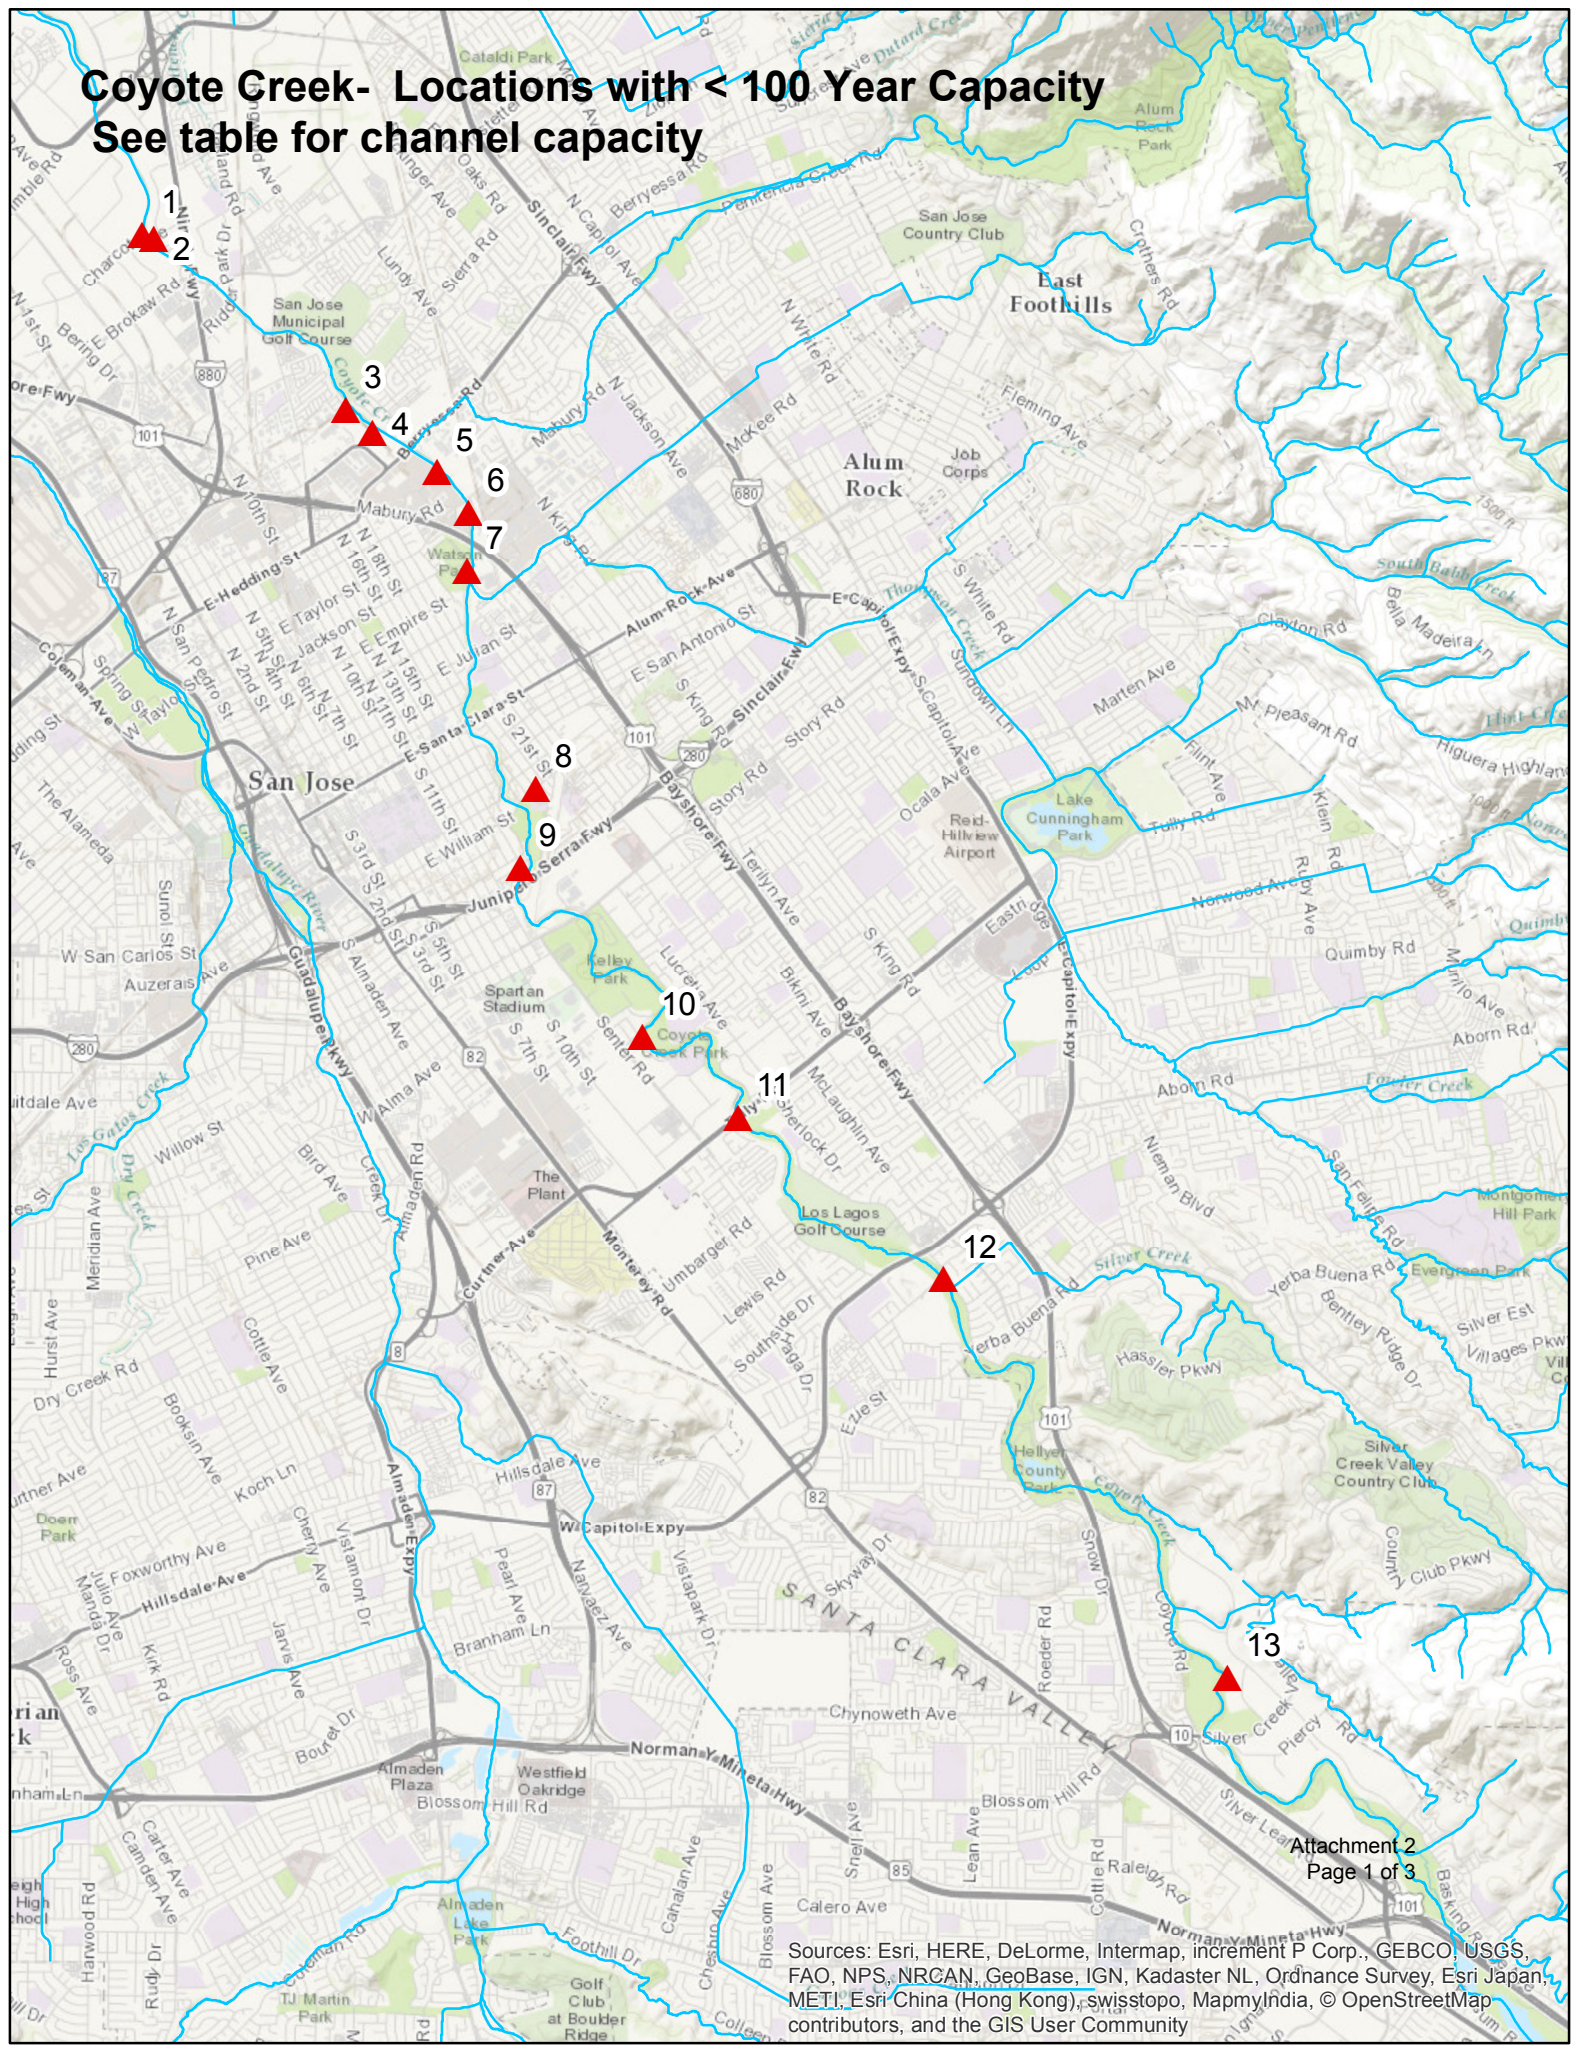
See table for channel capacity

ID #	Overtopping CFS	Flooding Description
1	11099	Breakout on West Bank, DS Charcot, flow travels d/s, eventually flooding structures.
2	10286	Breakout on East Bank, US Charcot- flow moves downstream, eventually flooding homes.
3	3517	Mobile Home Park Begins to flood (via gap in levee/floodwalls);entire mobile home area eventually floods.
4	2533	Q=2533 cfs- Structure N Berryessa and West of Creek floods. Q = 4363 Auto Glass Shop floods.
5	5599	Structures along west side of Coyote, South of Berryessa, North of Maybury, bgein to flood.
6	9040	Parklng Lot on West side begins to flood; structures affected at ~11000 cfs
7	4084	Park to the west of Coyote Creek Begins to flood. Park overtops & floods structures eventually.
8	11510	Selma Park on E Bank of Coyote has filled up; flow goes down S 19th St to flood homes to the NW;Selma park begins flooding at 6613 cfs.
9	11510	Williams St Park on W Bank of Coyote has filled up; flow begins to flood structures to the NW.

10	7400	Rock Spring Neighborhood starts to flood
11	11800	Tully Overtops
12	1000	Singleton Road Overtops (Less than 1000 CFS, starts the simulation inundated)
13	6700	Fontanoso Way Gap"" gap in floodwall protecting industrial park begins to flood
14	9870	Coyote Creek, North-West of Ogier Ponds floods, Coyote Valley Resort & RV, and some business on the creek side of Coyote begin flooding
15	5820	Scyamore Avenue that is protecting Santa Clara County Boy's Ranch overtops
16	5880	Sycamore Avenue Bridge
17	11870	Santa Clara County Justice Training Center begins to flood

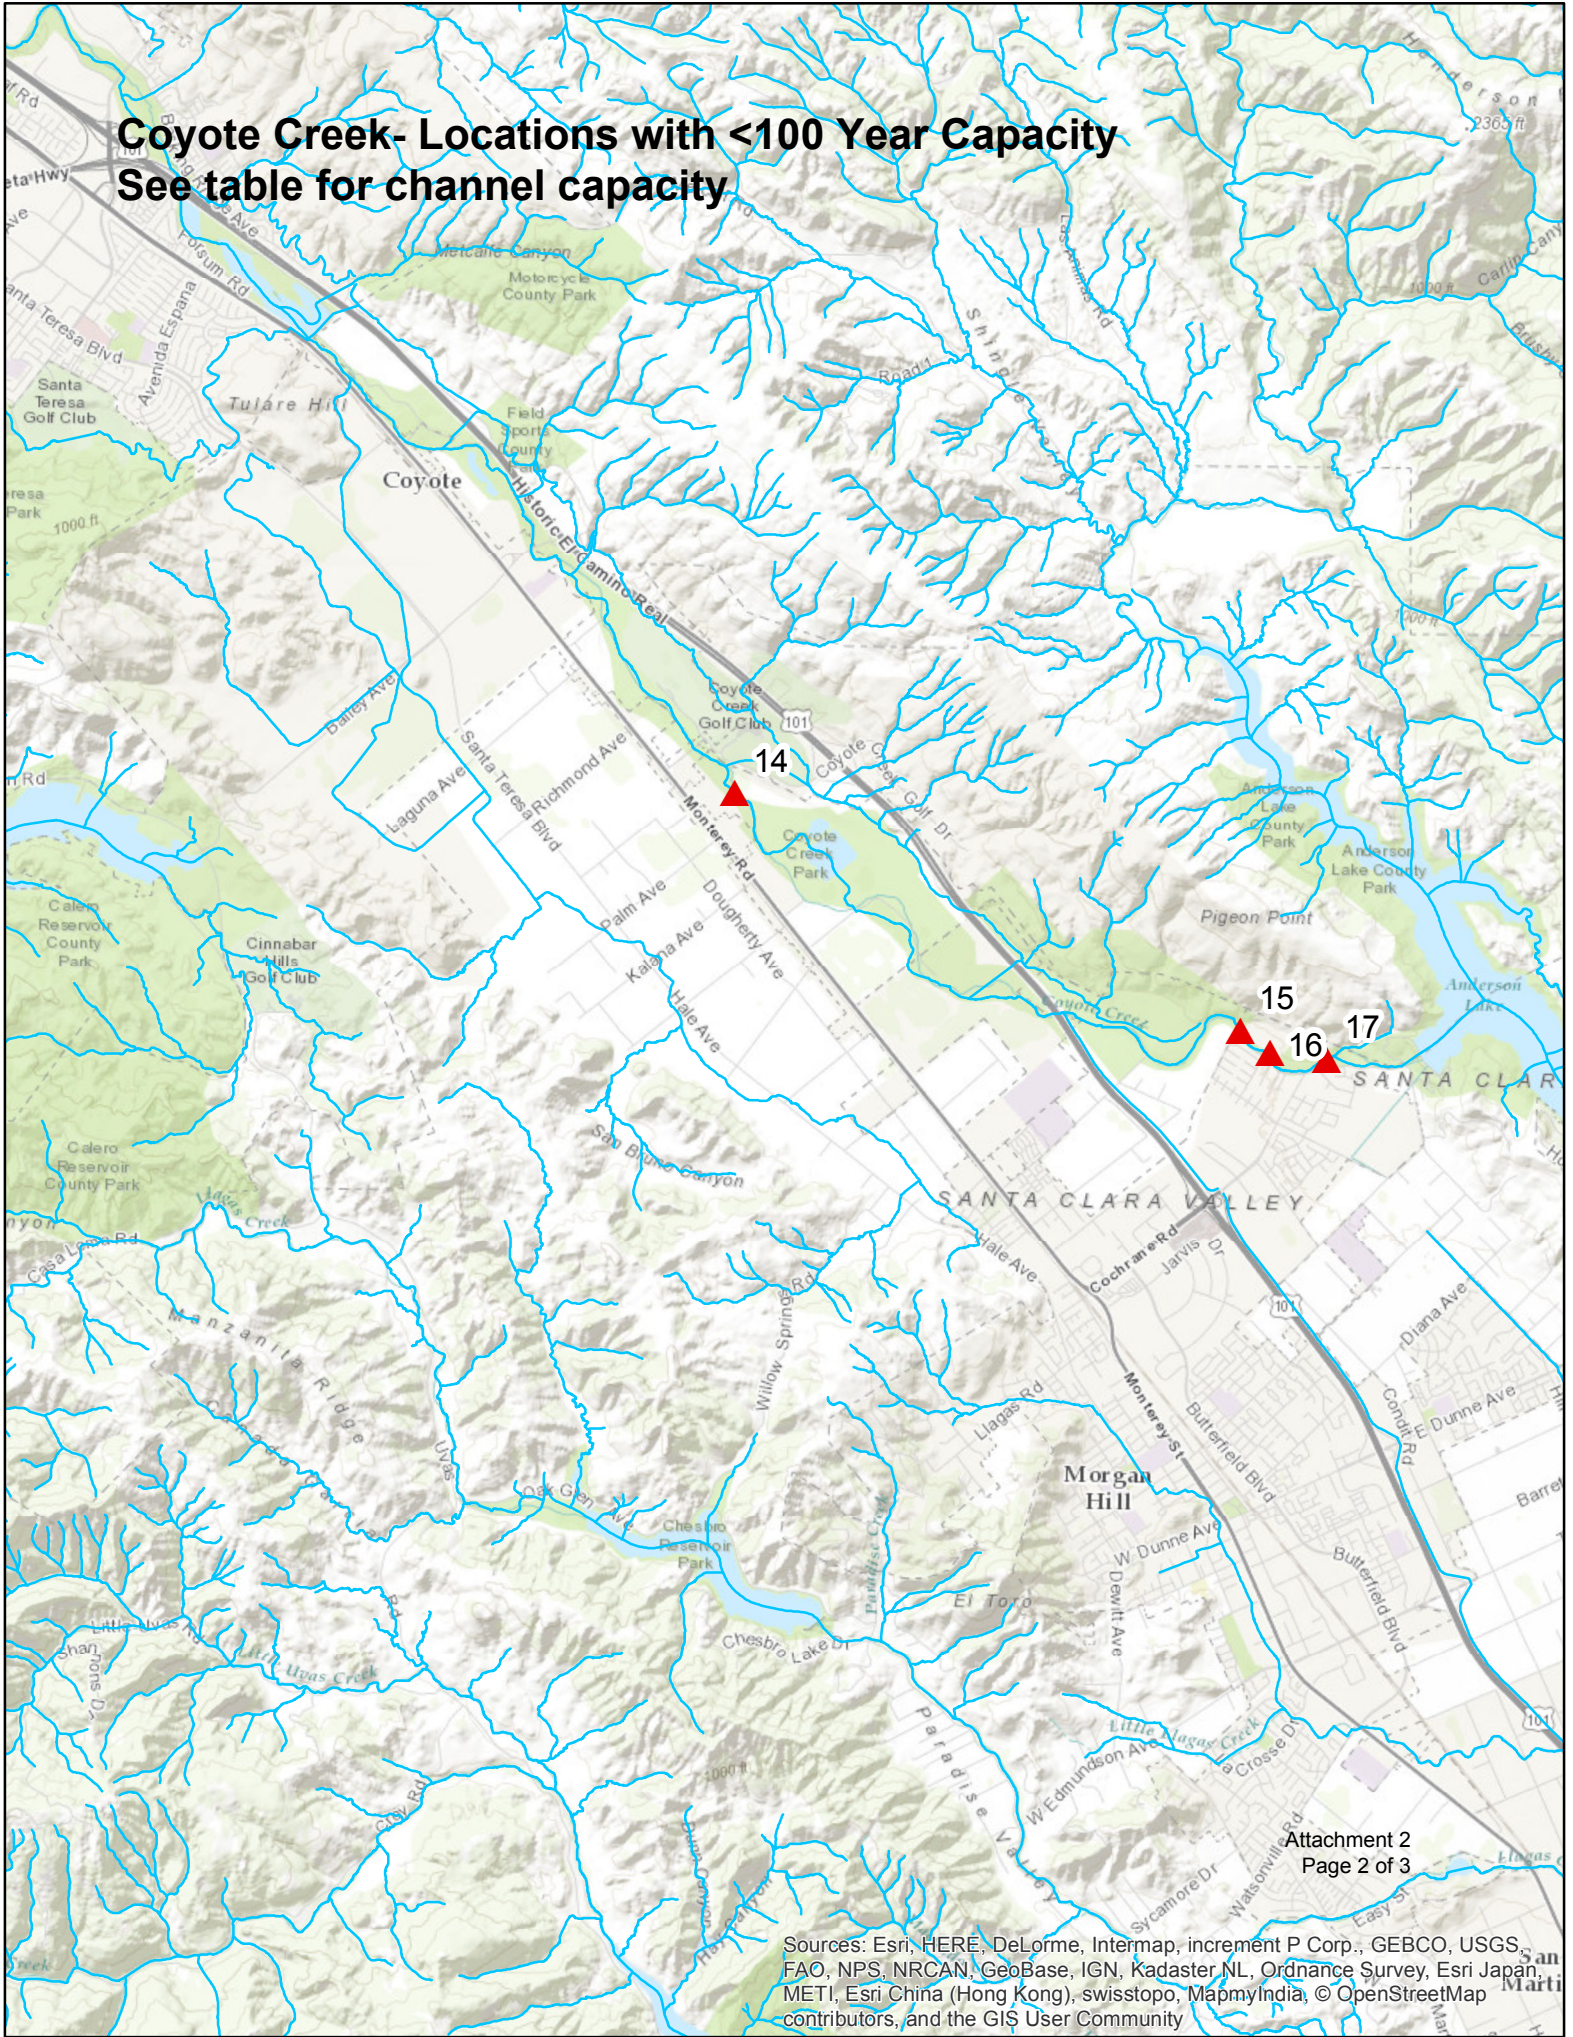
Coyote Creek- Locations with <100 Year Capacity

See table for channel capacity
