Phase I Hazardous Substance Liability Assessment (HSLA) Amy Lawrence APN 825-37-021 **13140 Llagas Avenue** San Martin, California 95046

Santa Clara Valley Water District 12/12/16 5750 Almaden Expressway San Jose, California 95118

849.01.55

PHASE I HAZARDOUS SUBSTANCE LIABLITY ASSESSMENT (HSLA) **AMY LAWRENCE** LLAGAS CREEK FLOOD PROTECTION PROJECT

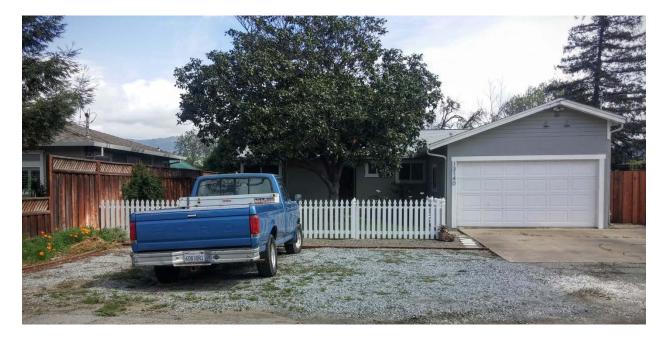
PLATE 3 APNs: 825-37-021 Address: 13140 Llagas Avenue

It should be noted that NCE was not provided access to the Site as the propeorty owner did not provide the District with a Right-of-Entry Agreement (ROE). The Site description provided and observations made were solely from viewing the property from Llagas Avenue.

Photo 1: View of Site from the adjoining roadway, Llagas Avenue.

- 1. Based on the agricultural history of the Site, NCE recommends sampling and testing the surficial and shallow soils for persistent pesticides and metals from those areas of the Site that will be acquired by the District.
- 2. Because naturally occurring asbestos may be present, NCE recommends sampling and testing surficial and shallow soils for asbestos.
- 3. Because the Site and particularly the ROW was not accessed, NCE recommends that the District obtain Site access from the owner and that those portions of the Site be observed to evaluate the potential for environmental concerns.
