## MEMORANDUM

**SUBJECT:** Emergency Declaration to Repair Stevens  
Creek Bank. Pursuant to Public Contract  
Code §22050

**DATE:** August 18, 2017

Attachment 1: Site Photographs

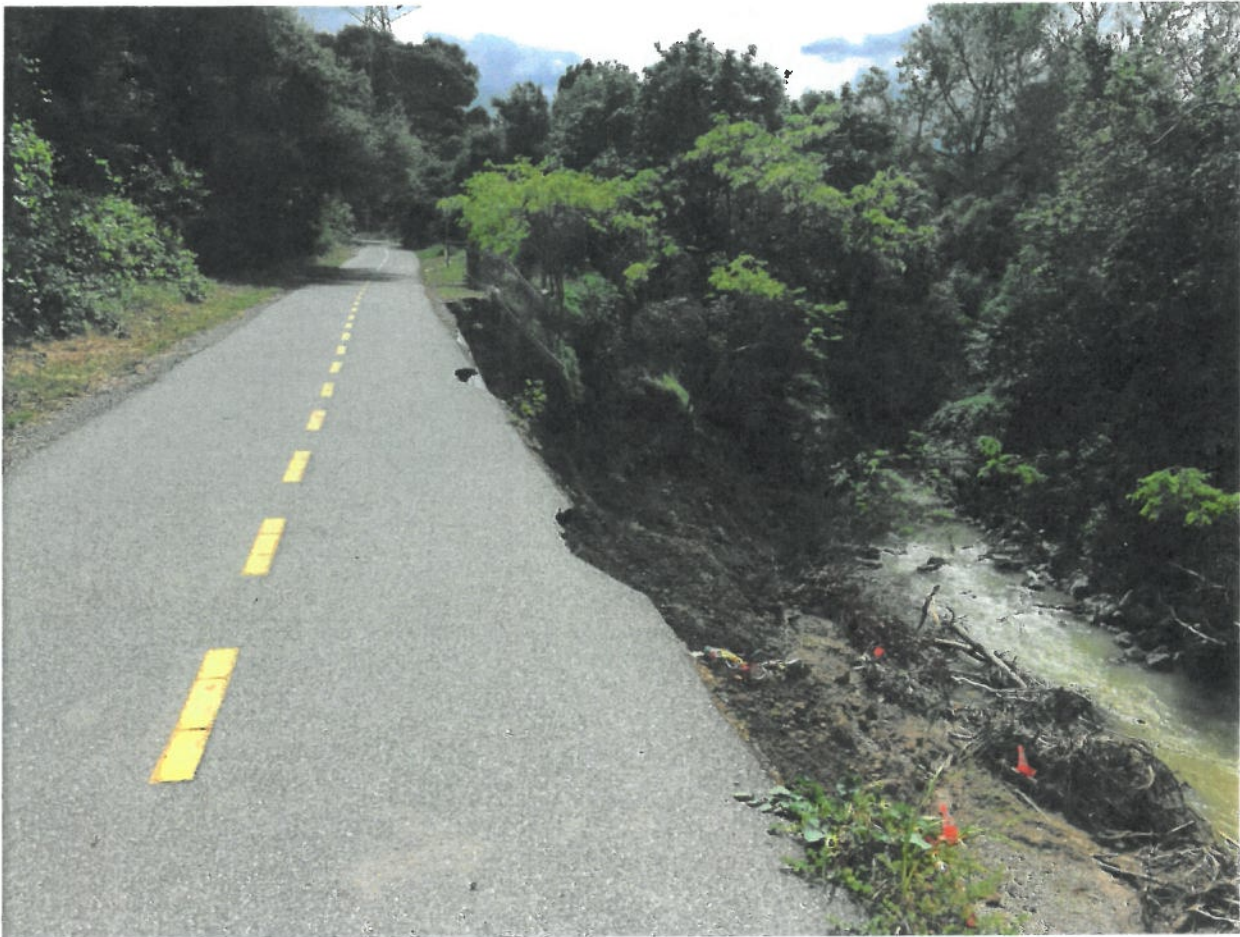
Photo 1: Looking southerly at bank failure along east bank (April 2017)

The sustained high flows and weakened soils caused a localized landslide approximately 180 feet in length, which resulted in enabling many trees, that were previously either removed or cut and left in place, to fall into the creek. This localized bank failure has left exposed a 25 foot-near vertical wall with loose material accumulating at the toe of original creek bank. The overall height of the bank failure from the creek bottom to the top of asphalt-paved trail is approximately 35 feet.

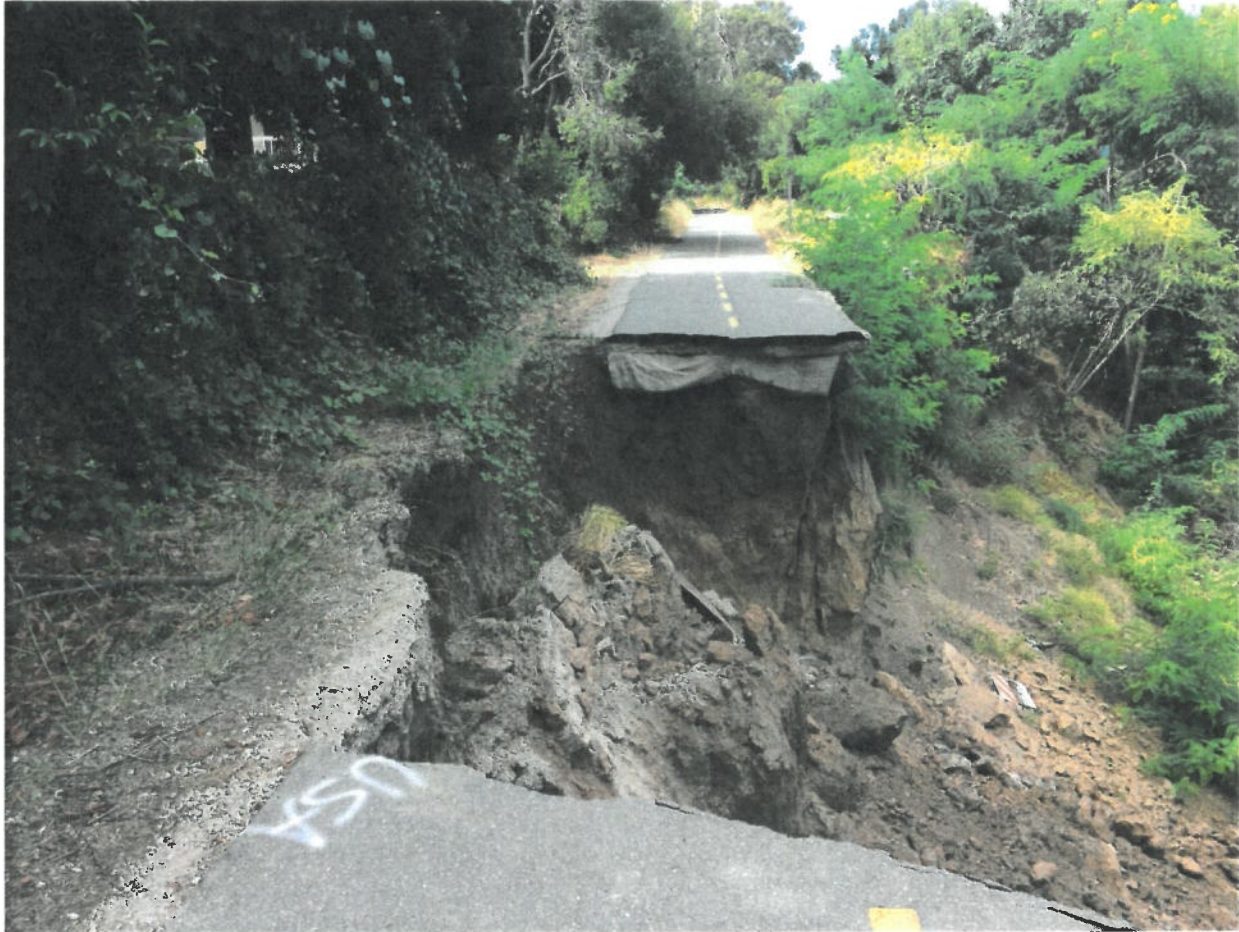
Photo 2: Looking southerly at bank failure along east bank (August 2017)

This recent creek bank sloughing created a 60-foot long gap within the District's maintenance access road (Attachment 1), which is considered an essential facility to maintain the District's watershed asset.

On August 11, 2017, City of Mountain View staff informed the District of additional soil loss along the creek trail, with the potential to erode the recently completed temporary paved trail located between the hotel and a chain link fence barrier. Subsequent site reconnaissance indicates the bank failure continues to grow in width and length, and is approximately five to six feet away from compromising the structural integrity of the temporary trail, in addition to undermining several redwood trees within the vicinity. The extent and severity of the continued erosion was unexpected.

There is not adequate time to complete a formal competitive bidding process to procure contractors to complete the work to arrest the erosion before the start of the rain season (October 15). Staff must immediately begin work with a qualified contractor to stop the erosion. The emergency work will not result in restoration of the road, but just stop the erosion from progressing. A larger capital project to restore the road is planned to be undertaken next year.

If the emergency action is not taken, the erosion will likely result in the loss of the temporary trail and collapse of additional segments of the District maintenance road. As recommended by our geotechnical consultant, Cal Engineering & Geology, Inc., Dan Peluso, G.E., emergency repairs must be undertaken to arrest further erosion, which poses an imminent threat to the temporary public trail segment, District maintenance road and adjacent property. Absent the emergency action, high flows in the creek coupled with saturation of the eroded embankment will likely hasten the already alarming rate of soil erosion.
