Project F1: Vegetation Control and Sediment Removal for Capacity Supplemental information to the Management Response to IMC Recommendations

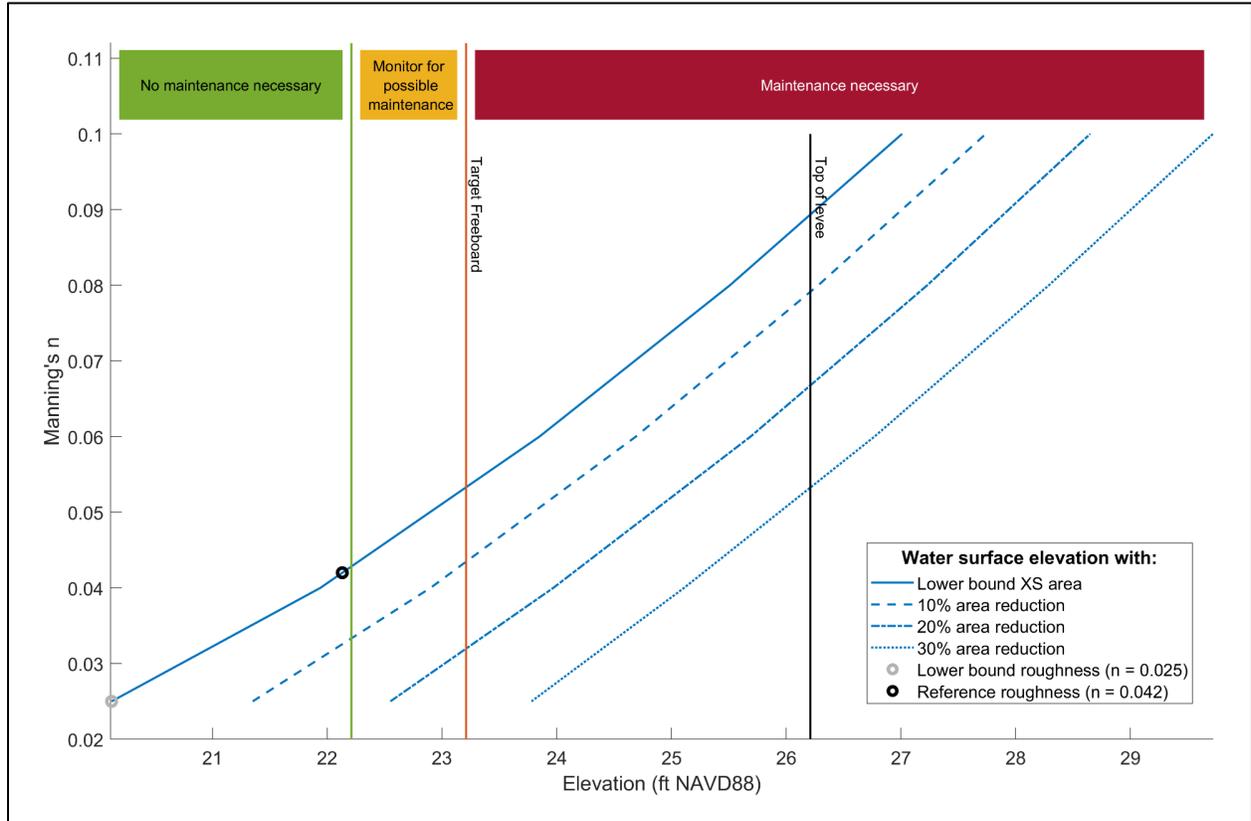
Figure 1: Example Stream Maintenance Guideline Nomograph for Calabazas Creek, Reach 1c

Figure 1 is an example chart or nomograph for a reach of Calabazas Creek downstream of Highway 101 in Santa Clara. This nomograph captures a particular cross-section of Calabazas Creek, intended to be representative of that reach of creek. The x-axis represents water surface elevation. The y-axis represents Manning's n (roughness coefficient). Each of the blue lines represents sediment accumulation scenarios with the left-most line ("Lower bound XS area") representing the cross-section with no additional sediment accumulation. Each of the subsequent blue lines represents different sediment accumulation scenarios (i.e., reduction in channel cross-sectional area relative to the lower bound condition). While this is an example of one creek reach, nomographs are being developed for multiple reaches of multiple creeks for which a flood protection project has been completed. The development of such nomographs is based on manifold runs of hydraulic models.

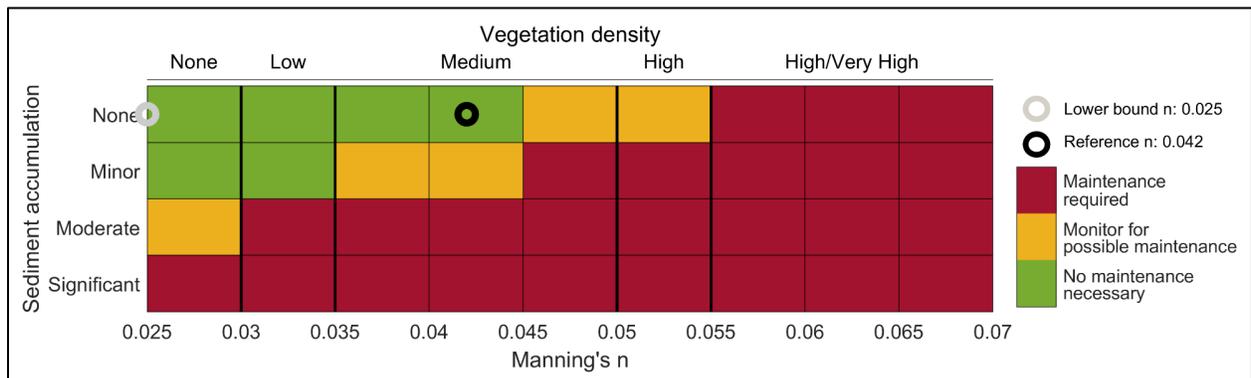
Figure 2: Example Stream Maintenance Guideline Summary Thresholds for Maintenance for Calabazas Creek, Reach 1c

Figure 2 is a more simplified version of the nomograph, providing summary thresholds for maintenance of this reach of Calabazas Creek. Vegetation density and sediment accumulation remain key factors under consideration. Green squares represent conditions under which the target freeboard is met for the LOS flow. Yellow squares represent vegetation/sediment conditions under which the target freeboard is met for the LOS flow, but monitoring is recommended. Red squares represent conditions under which the target freeboard is not met for the LOS flow and maintenance may be required.
